Access Compliance Report

Public Rights-of-Way

(Curb Ramps)

Intersection ID: 44008	Main Street: ARCOLA_LN	Cross Street: DEMAINE_DR	Location: S
ADA ID: 94CACE2D6E14	Ramp Type: PerpDiag	Initial Pass/Fail: Fail	Overall Compliance: No
Severity Score: 31.25			
Codes/Mitigation Info/Possible Solution		Field Measurements/Component Compliance

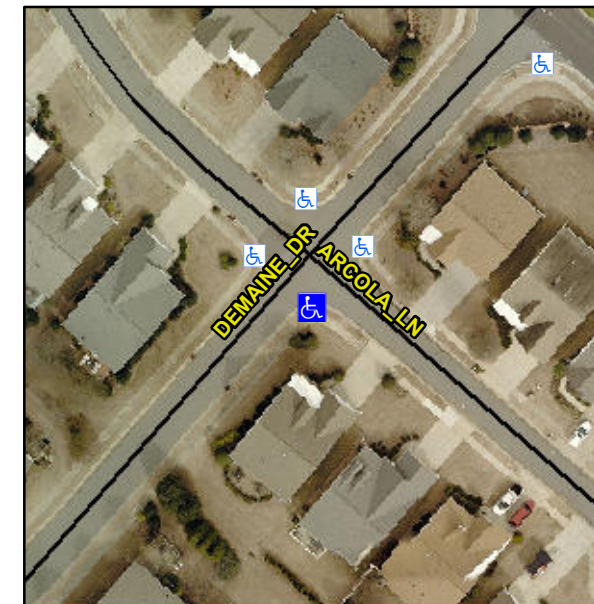
Not Found, R304.5.1, R304.2.2, R304.5.3

Compliance	Description	Data	Compliance	Description	Data
N/A	Ramp Length (in)	44.0	No	Ramp Slope (%)	10.1
No	Ramp Width (in)	34.0	No	Ramp XSlope (%)	2.6
N/A	Flare Type LT	N/A	N/A	Flare Type RT	N/A
N/A	Flare Slope LT (%)	N/A	N/A	Flare Slope RT (%)	N/A
N/A	Flare Traversable LT?	N/A	N/A	Flare Traversable RT?	N/A
N/A	Landing Length (in)	N/A	N/A	DWS Provided?	N/A
N/A	Landing Width (in)	N/A	N/A	DWS Contrast?	N/A
N/A	Landing Slope (%)	N/A	N/A	DWS Length (in)	N/A
N/A	Landing X Slope (%)	N/A	N/A	DWS Full Width?	N/A
N/A	Landing Curb? (Y/N)	N/A	N/A	DWS Offset (in)	N/A
N/A	Shared Landing?	N/A			
N/A	Gutter Ponding?	N/A	N/A	Gutter Slope (%)	N/A
N/A	Gutter Lip Ht (in)	N/A	N/A	Gutter X Slope (%)	N/A
N/A	Painted X Walk1?	No	N/A	Painted X Walk2?	No
	X Walk 1 Direction	To NE		X Walk 2 Direction	To NW
N/A	X Walk 1 Width (in)	N/A	N/A	X Walk 2 Width (in)	N/A
	X Walk 1 Slope (%)	2.8		X Walk 2 Slope (%)	3.2
	X Walk 1 X Slope (%)	2.6		X Walk 2 X Slope (%)	1.9

N/A	Ramp inside XWalk1?	N/A	N/A	Ramp inside XWalk2?	N/A
	Road Slope (%)	0.9	N/A	Clear Space?	N/A
	Road X Slope (%)	5.3	N/A	Clear Space to XWalk (in)	N/A
N/A	Any Obstructions?	N/A	N/A	Storm Grate/Utility Hazard?	N/A
	Obstruction Type			Storm Grate/Utility Type	
		N/A			N/A
			Yes	Surface Condition? (G/P)	Good

Remove & Replace Curb Ramp With Two New Directional Ramps or Equivalent.
