Access Compliance Report

Public Rights-of-Way

(Curb Ramps)

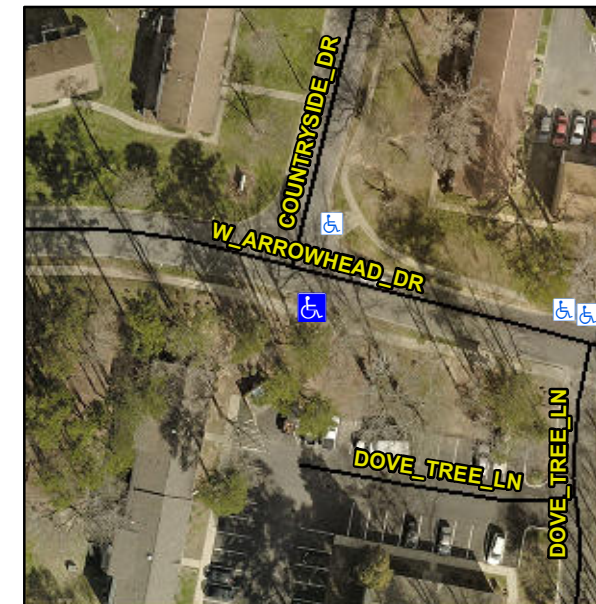
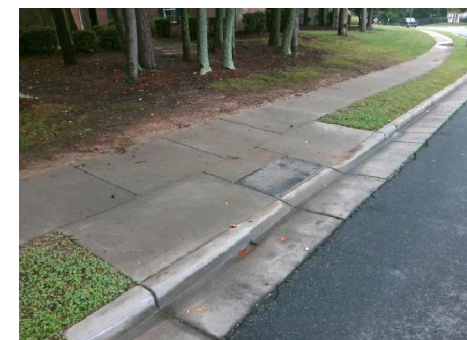
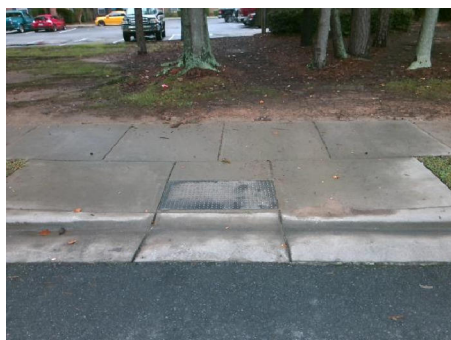
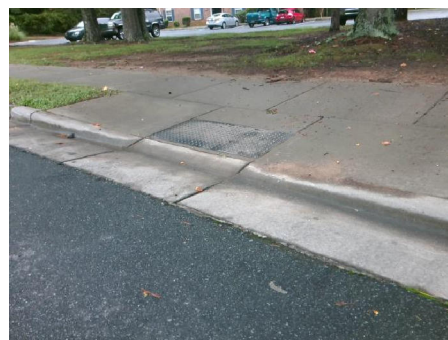
Intersection ID: 7728	Main Street: COUNTRYSIDE_DR	Cross Street: W_ARROWHEAD_DR	Location: SE
ADA ID: 94D8CC37E673	Ramp Type: BlendTrans1	Initial Pass/Fail: Fail	Overall Compliance: No
Severity Score: 10			
Codes/Mitigation Info/Possible Solution		Field Measurements/Component Compliance

Not Found, R304.5.1, R304.5.3

Compliance	Description	Data	Compliance	Description	Data
N/A	Ramp Length (in)	47.0	Yes	BlendTrans Slope (%)	3.4
No	Ramp Width (in)	47.5	No	BlendTrans XSlope (%)	2.4
N/A	Flare Type LT	N/A	N/A	Flare Type RT	N/A
N/A	Flare Slope LT (%)	N/A	N/A	Flare Slope RT (%)	N/A
N/A	Flare Traversable LT?	N/A	N/A	Flare Traversable RT?	N/A
N/A	Landing Length (in)	N/A	N/A	DWS Provided?	N/A
N/A	Landing Width (in)	N/A	N/A	DWS Contrast?	N/A
N/A	Landing Slope (%)	N/A	N/A	DWS Length (in)	N/A
N/A	Landing X Slope (%)	N/A	N/A	DWS Full Width?	N/A
N/A	Landing Curb? (Y/N)	N/A	N/A	DWS Offset (in)	N/A
N/A	Shared Landing?	N/A			
N/A	Gutter Ponding?	N/A	N/A	Gutter Slope (%)	N/A
N/A	Gutter Lip Ht (in)	0.5	N/A	Gutter X Slope (%)	N/A
N/A	Painted X Walk1?	No	N/A	Painted X Walk2?	N/A
	X Walk 1 Direction	To NE		X Walk 2 Direction	N/A
	X Walk 1 Width (in)	N/A		X Walk 2 Width (in)	N/A
	X Walk 1 Slope (%)	5.2		X Walk 2 Slope (%)	N/A
	X Walk 1 X Slope (%)	1.3		X Walk 2 X Slope (%)	N/A

N/A	Ramp inside XWalk1?	N/A	N/A	Ramp inside XWalk2?	N/A
	Road Slope (%)	1.3		Clear Space?	N/A
	Road X Slope (%)	5.2	N/A	Clear Space to XWalk (in)	N/A
N/A	Any Obstructions?	N/A	N/A	Storm Grate/Utility Hazard?	N/A
	Obstruction Type			Storm Grate/Utility Type	
		N/A			N/A
			Yes	Surface Condition? (G/P)	Good
			No	Curb Slope (%)	24.4

Remove & Replace Curb Ramp With Two New Directional Ramps or Equivalent.
