# Access Compliance Report

## Public Rights-of-Way

### (Curb Ramps)

Intersection ID: 49130	Main Street: AUBURN_HILL_LN	Cross Street: WILTSHIRE_RIDGE_RD	Location: NW
ADA ID: 94E4F540EA83	Ramp Type: Perp	Initial Pass/Fail: Fail	Overall Compliance: No
Severity Score: 10			
Codes/Mitigation Info/Possible Solution		Field Measurements/Component Compliance

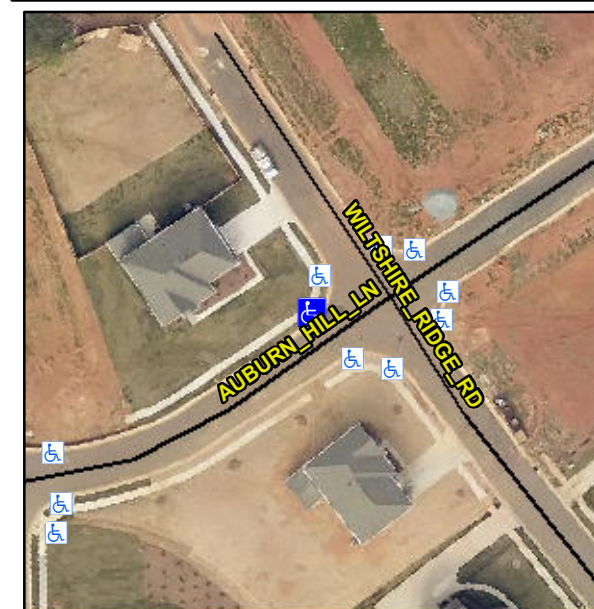
**N/A**

**Not Found, R304.5.1**

Compliance	Description	Data	Compliance	Description	Data
N/A	Ramp Length (in)	48.0	Yes	Ramp Slope (%)	5.0
No	Ramp Width (in)	46.0	Yes	Ramp XSlope (%)	3.3
N/A	Flare Type LT	N/A	N/A	Flare Type RT	N/A
N/A	Flare Slope LT (%)	N/A	N/A	Flare Slope RT (%)	N/A
N/A	Flare Traversable LT?	N/A	N/A	Flare Traversable RT?	N/A
N/A	Landing Length (in)	N/A	N/A	DWS Provided?	N/A
N/A	Landing Width (in)	N/A	N/A	DWS Contrast?	N/A
N/A	Landing Slope (%)	N/A	N/A	DWS Length (in)	N/A
N/A	Landing X Slope (%)	N/A	N/A	DWS Full Width?	N/A
N/A	Landing Curb? (Y/N)	N/A	N/A	DWS Offset (in)	N/A
N/A	Shared Landing?	N/A			
N/A	Gutter Ponding?	N/A	N/A	Gutter Slope (%)	N/A
N/A	Gutter Lip Ht (in)	N/A	N/A	Gutter X Slope (%)	N/A
N/A	Painted X Walk1?	No	N/A	Painted X Walk2?	N/A
	X Walk 1 Direction	To S		X Walk 2 Direction	N/A
N/A	X Walk 1 Width (in)	N/A	N/A	X Walk 2 Width (in)	N/A
	X Walk 1 Slope (%)	3.4		X Walk 2 Slope (%)	N/A
	X Walk 1 X Slope (%)	4.0		X Walk 2 X Slope (%)	N/A

N/A	Ramp inside XWalk1?	N/A	N/A	Ramp inside XWalk2?	N/A
	Road Slope (%)	N/A	N/A	Clear Space?	N/A
	Road X Slope (%)	N/A	N/A	Clear Space to XWalk (in)	N/A
N/A	Any Obstructions?	N/A	N/A	Storm Grate/Utility Hazard?	N/A
	Obstruction Type			Storm Grate/Utility Type	
		N/A			N/A
			Yes	Surface Condition? (G/P)	Good

**Remove & Replace Entire Ramp.**

Total Cost: \$ 1850.00
