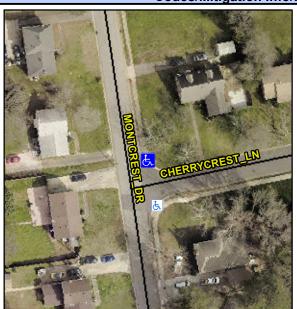
Intersection ID: 20038Main Street:CHERRYCREST\_LNCross Street:MONTCREST\_DRLocation:NEADA ID: 94F55AF87AC1Ramp Type:PerpDiagInitial Pass/Fail:FailOverall Compliance:NoSeverity Score:21.25

Not Found, R304.5.1, R304.5.3

| Field Measurements/Component Compnance | | | | | | |
|--|---|---|---|---|---|---|
| | No | Ramp Width (in) | 47.5 | No | Ramp XSlope (%) | 5.4 |

Remove & Replace Curb Ramp With Two New Directional Ramps or Equivalent.

Total Cost: \$ 3200.00
