# Access Compliance Report

## Public Rights-of-Way

### (Curb Ramps)

Intersection ID: 4064		Main Street: DAVID_COX_RD		Cross Street: MERLOT_LN		Location: NE											
ADA ID: 94FA89A9150A		Ramp Type: Directional1		Initial Pass/Fail: Fail		Overall Compliance: No		Severity Score: 26.25									
Codes/Mitigation Info/Possible Solution				Field Measurements/Component Compliance													
<div>

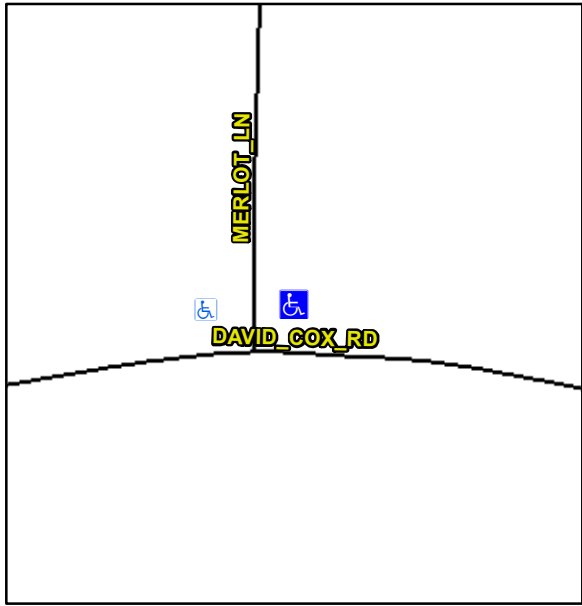
</div> <div>Street 1 NameDAVID COX RD</div> <div>Stop Condition-Street 1StopSign</div> <div>Street 2 NameN/A</div> <div>Stop Condition-Street 2N/A</div>				Possible Solutions:		Compliance		Description		Data		Compliance		Description		Data	
				Remove & Replace Entire Ramp.		N/A		Ramp Length (in)		31.0		N/A		Grade Break?		N/A	
Surveyor Notes:				N/A		Yes		Ramp Width (in)		50.0		N/A		Grade Break Slope (%)		0.0	
						No		Ramp Slope (%)		12.3		N/A		Grade Break XSlope (%)		0.0	
PROW/ADA:				R304.2.2, R304.5.3		No		Ramp XSlope (%)		2.1							
						N/A		Flare Type LT		N/A		N/A		Flare Type RT		N/A

N/A		Flare Slope LT (%)		N/A		N/A		Flare Slope RT (%)		0.0	
						N/A		Flare Traversable LT?		N/A		N/A		Flare Traversable RT?		N/A	
						N/A		Landing Length (in)		0.0		N/A		DWS Provided?		N/A	
						N/A		Landing Width (in)		0.0		N/A		DWS Contrast?		N/A	
						N/A		Landing Slope (%)		0.0		N/A		DWS Length (in)		N/A	
						N/A		Landing X Slope (%)		0.0		N/A		DWS Full Width?		N/A	
						N/A		Landing Curb? (Y/N)		N/A		N/A		DWS Offset LT (in)		N/A	
						N/A		Shared Landing?		N/A		N/A		DWS Offset RT (in)		N/A	
						N/A		Gutter Ponding?		0.0		N/A		Gutter Slope (%)		N/A	
						N/A		Gutter Lip Ht (in)		0.0		N/A		Gutter X Slope (%)		N/A	
						N/A		Painted X Walk1?		No				Road Slope (%)		4.1	
								X Walk 1 Direction		To SW				Road X Slope (%)		0.5	
								X Walk 1 Width (in)		N/A				Clear Space?		N/A	
								X Walk 1 Slope (%)		4.1		N/A		Clear Space to XWalk (in)		N/A	
								X Walk 1 X Slope (%)		0.5		N/A		Storm Grate/Utility Hazard?		N/A

N/A		Ramp inside XWalk1?		N/A				Storm Grate/Utility Type			
						N/A		Any Obstructions?		N/A						N/A	
								Obstruction Type				Yes		Surface Condition? (G/P)		Good	
										N/A		N/A		Curb Slope (%)		17.5	
Total Cost:				\$		1600.00
