# Access Compliance Report

## Public Rights-of-Way

### (Curb Ramps)

Intersection ID: 15542	Main Street: CLANTON_RD	Cross Street: N_CLANTON_TO_S_I-77_RA	Location: NW
ADA ID: 94FFE8464CD0	Ramp Type: Perp	Initial Pass/Fail: Fail	Overall Compliance: No
		Severity Score: 12.5

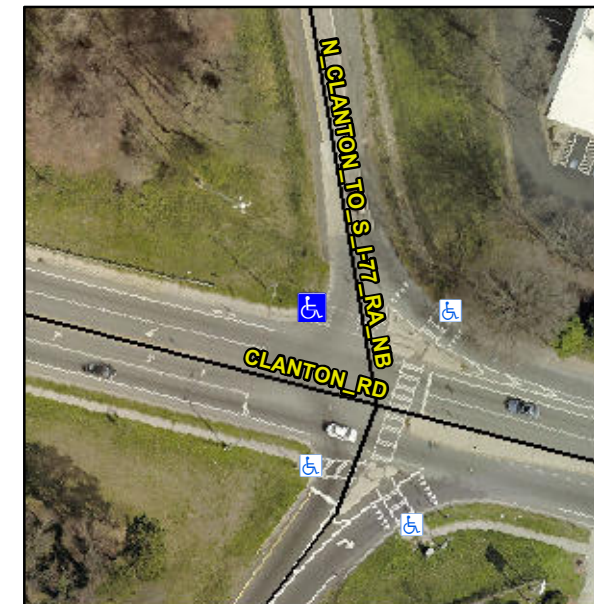
Compliance	Description	Data	Compliance	Description	Data
N/A	Ramp Length (in)	56.0	No	Ramp Slope (%)	8.9
Yes	Ramp Width (in)	48.0	Yes	Ramp XSlope (%)	1.8
N/A	Flare Type LT	N/A	N/A	Flare Type RT	N/A
N/A	Flare Slope LT (%)	N/A	N/A	Flare Slope RT (%)	N/A
N/A	Flare Traversable LT?	N/A	N/A	Flare Traversable RT?	N/A
N/A	Landing Length (in)	N/A	N/A	DWS Provided?	N/A
N/A	Landing Width (in)	N/A	N/A	DWS Contrast?	N/A
N/A	Landing Slope (%)	N/A	N/A	DWS Length (in)	N/A
N/A	Landing X Slope (%)	N/A	N/A	DWS Full Width?	N/A
N/A	Landing Curb? (Y/N)	N/A	N/A	DWS Offset (in)	N/A
N/A	Shared Landing?	N/A			
N/A	Gutter Ponding?	N/A	N/A	Gutter Slope (%)	N/A
N/A	Gutter Lip Ht (in)	N/A	N/A	Gutter X Slope (%)	N/A
N/A	Painted X Walk1?	Yes	N/A	Painted X Walk2?	N/A
	X Walk 1 Direction	To SE		X Walk 2 Direction	N/A
N/A	X Walk 1 Width (in)	110.0	N/A	X Walk 2 Width (in)	N/A
	X Walk 1 Slope (%)	2.0		X Walk 2 Slope (%)	N/A
	X Walk 1 X Slope (%)	1.6		X Walk 2 X Slope (%)	N/A

N/A	Ramp inside XWalk1?	Yes	N/A	Ramp inside XWalk2?	N/A
	Road Slope (%)	N/A	N/A	Clear Space?	N/A
	Road X Slope (%)	N/A	N/A	Clear Space to XWalk (in)	N/A
N/A	Any Obstructions?	N/A	N/A	Storm Grate/Utility Hazard?	N/A
	Obstruction Type			Storm Grate/Utility Type	
		N/A			N/A
		Yes		Surface Condition? (G/P)	Good

Possible Solutions:

**Remove & Replace Entire Ramp.**

PROW/ADA:

**R304.2.2**
