Access Compliance Report

Public Rights-of-Way

(Curb Ramps)

Intersection ID: N/A	Main Street: BEREWICK COMMONS PKY	Cross Street: KELTON HILL LN	Location: NW
ADA ID: 95039229667B	Ramp Type: PerpDiag	Initial Pass/Fail: Fail	Overall Compliance: No
Severity Score: 10			
Codes/Mitigation Info/Possible Solution		Field Measurements/Component Compliance

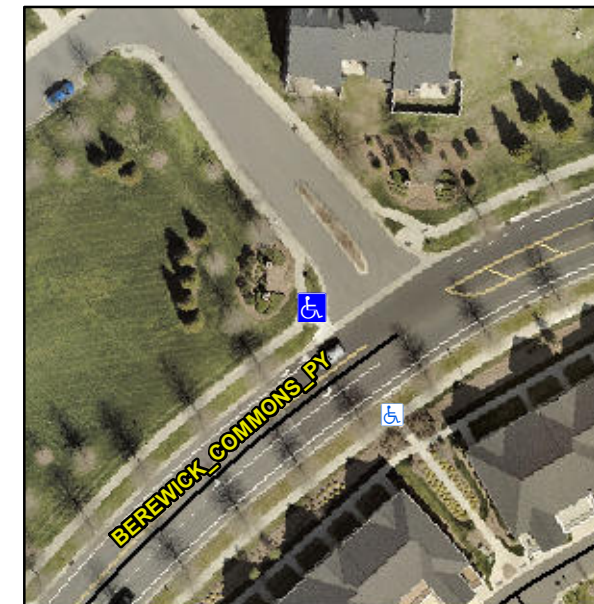
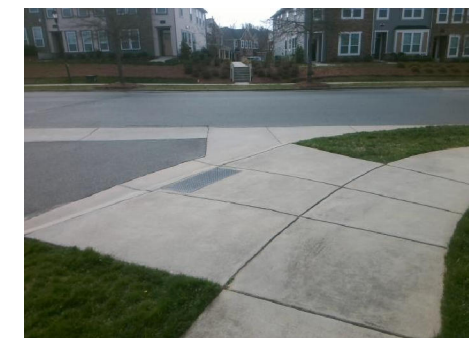
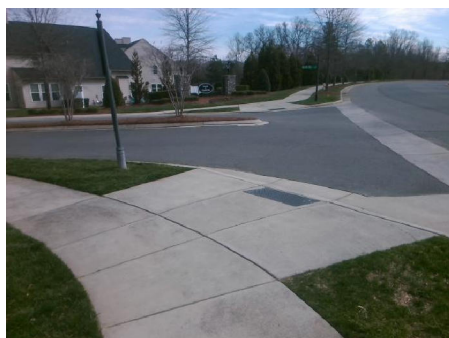
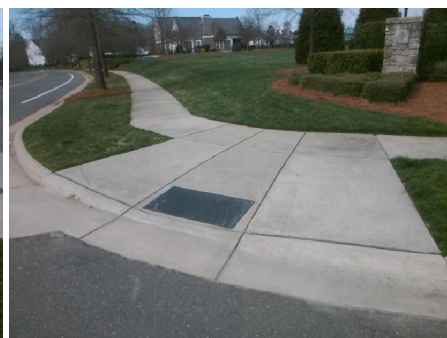
Compliance	Description	Data	Compliance	Description	Data
N/A	Ramp Length (in)	97.0	Yes	Ramp Slope (%)	7.5
No	Ramp Width (in)	42.0	No	Ramp XSlope (%)	2.4
N/A	Flare Type LT	N/A	N/A	Flare Type RT	N/A
N/A	Flare Slope LT (%)	N/A	N/A	Flare Slope RT (%)	N/A
N/A	Flare Traversable LT?	N/A	N/A	Flare Traversable RT?	N/A
N/A	Landing Length (in)	N/A	N/A	DWS Provided?	N/A
N/A	Landing Width (in)	N/A	N/A	DWS Contrast?	N/A
N/A	Landing Slope (%)	N/A	N/A	DWS Length (in)	N/A
N/A	Landing X Slope (%)	N/A	N/A	DWS Full Width?	N/A
N/A	Landing Curb? (Y/N)	N/A	N/A	DWS Offset (in)	N/A
N/A	Shared Landing?	N/A			
N/A	Gutter Ponding?	N/A	N/A	Gutter Slope (%)	N/A
N/A	Gutter Lip Ht (in)	0.5	N/A	Gutter X Slope (%)	N/A
N/A	Painted X Walk1?	No	N/A	Painted X Walk2?	No
	X Walk 1 Direction	To SE		X Walk 2 Direction	To NE
N/A	X Walk 1 Width (in)	N/A	N/A	X Walk 2 Width (in)	N/A
	X Walk 1 Slope (%)	4.7		X Walk 2 Slope (%)	1.2
	X Walk 1 X Slope (%)	2.4		X Walk 2 X Slope (%)	5.3

N/A	Ramp inside XWalk1?	N/A	N/A	Ramp inside XWalk2?	N/A
	Road Slope (%)	4.5	N/A	Clear Space?	N/A
	Road X Slope (%)	4.4	N/A	Clear Space to XWalk (in)	N/A
N/A	Any Obstructions?	N/A	N/A	Storm Grate/Utility Hazard?	N/A
	Obstruction Type			Storm Grate/Utility Type	
		N/A			N/A
			Yes	Surface Condition? (G/P)	Good

Remove & Replace Curb Ramp With Two New Directional Ramps or Equivalent.
