Access Compliance Report Public Rights-of-Way (Curb Ramps)

Intersection ID: 19055 Main Street: MONROE_RD Cros					oss Street: LUMARKA_DR				NE
								Location:	
ADA ID: 9509EBEC07B7 Ramp Type: PerpDiag			Initial I	Initial Pass/Fail: Fail Overall Compliance: No					33.75
Codes/Mitigation Info/Possible Solution				Field Measurements/Component Compliance					
A ANTIMATIN AND AND	LULING BRAND	Possible Solutions:		Compliance Description			Data Compliance Description		Data
		Remove & Replace Curb Ramp W Two New Directional Ramps or Equivalent.	p With	N/A	Ramp Length (in)	58.0	No	Ramp Slope (%)	9.5
			r	No	Ramp Width (in)	40.0	No	Ramp XSlope (%)	5.9
				N/A	Flare Type LT	N/A	N/A	Flare Type RT	N/A
				N/A	Flare Slope LT (%)	N/A	N/A	Flare Slope RT (%)	N/A
				N/A	Flare Traversable LT?	N/A	N/A	Flare Traversable RT?	N/A
and the second				N/A	Landing Length (in)	N/A	N/A	DWS Provided?	N/A
		Surveyor Notes:		N/A	Landing Width (in)	N/A	N/A	DWS Contrast?	N/A
		N/A		N/A	Landing Slope (%)	N/A	N/A	DWS Length (in)	N/A

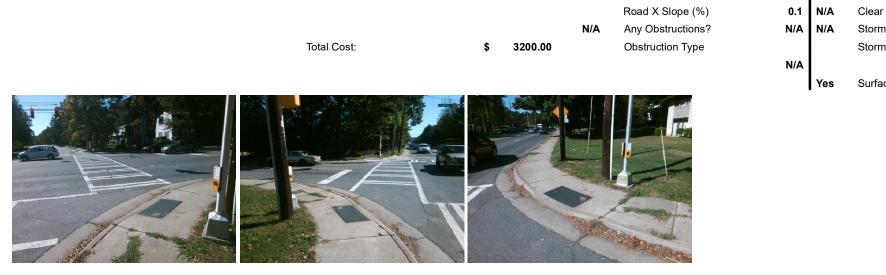
N/A	Landing X Slope (%)	N/A	N/A	DWS Full Width?	N/A
				N/A	Landing Curb? (Y/N)	N/A	N/A	DWS Offset (in)	N/A
L A				N/A	Shared Landing?	N/A			
SP		PROW/ADA:		N/A	Gutter Ponding?	N/A	N/A	Gutter Slope (%)	N/A
A CONTRACT OF		Not Found, R304.5.1, R304.2.2,	2,	N/A	Gutter Lip Ht (in)	N/A	N/A	Gutter X Slope (%)	N/A
THE CASE OF A		R304.5.3	,	N/A	Painted X Walk1?	Yes	N/A	Painted X Walk2?	Yes
	HA C				X Walk 1 Direction	To SW		X Walk 2 Direction	To SE
13 0	16182			N/A	X Walk 1 Width (in)	112.0	N/A	X Walk 2 Width (in)	100.0
Street 1 Name	MONROE RD				X Walk 1 Slope (%)	0.9		X Walk 2 Slope (%)	1.9
Stop Condition-Street 2	Signal				X Walk 1 X Slope (%)	2.5		X Walk 2 X Slope (%)	0.9
Street 2 Name	LUMARKA DR			N/A	Ramp inside XWalk1?	Yes	N/A	Ramp inside XWalk2?	Yes
Stop Condition-Street 1	Signal				Road Slope (%)	2.9	N/A	Clear Space?	N/A
					Road X Slope (%)	0.1	N/A	Clear Space to XWalk (in)	N/A
				N/A	Any Obstructions?	N/A	N/A	Storm Grate/Utility Hazard?	N/A

Total Cost: \$	3200.00		Obstruction Type			Storm Grate/Utility Type	
						N/A			N/A
