# Access Compliance Report

## Public Rights-of-Way

### (Curb Ramps)

Intersection ID: 46237	Main Street: LINDEN_RIDGE_LN	Cross Street: MCINTYRE_AV	Location: SE
ADA ID: 9525EC0D8B8D	Ramp Type: Perp	Initial Pass/Fail: Fail	Overall Compliance: No
Severity Score: 12.5			
Codes/Mitigation Info/Possible Solution		Field Measurements/Component Compliance

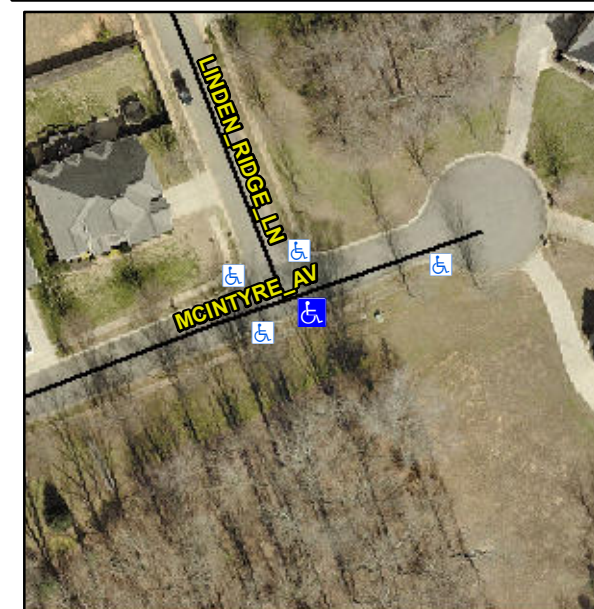
**Not Found, R304.5.3**

Compliance	Description	Data	Compliance	Description	Data
N/A	Ramp Length (in)	47.0	Yes	Ramp Slope (%)	6.8
Yes	Ramp Width (in)	48.5	No	Ramp XSlope (%)	5.1
N/A	Flare Type LT	N/A	N/A	Flare Type RT	N/A
N/A	Flare Slope LT (%)	N/A	N/A	Flare Slope RT (%)	N/A
N/A	Flare Traversable LT?	N/A	N/A	Flare Traversable RT?	N/A
N/A	Landing Length (in)	N/A	N/A	DWS Provided?	N/A
N/A	Landing Width (in)	N/A	N/A	DWS Contrast?	N/A
N/A	Landing Slope (%)	N/A	N/A	DWS Length (in)	N/A
N/A	Landing X Slope (%)	N/A	N/A	DWS Full Width?	N/A
N/A	Landing Curb? (Y/N)	N/A	N/A	DWS Offset (in)	N/A
N/A	Shared Landing?	N/A			
N/A	Gutter Ponding?	N/A	N/A	Gutter Slope (%)	N/A
N/A	Gutter Lip Ht (in)	N/A	N/A	Gutter X Slope (%)	N/A
N/A	Painted X Walk1?	No	N/A	Painted X Walk2?	N/A
	X Walk 1 Direction	To N		X Walk 2 Direction	N/A
N/A	X Walk 1 Width (in)	N/A	N/A	X Walk 2 Width (in)	N/A
	X Walk 1 Slope (%)	2.3		X Walk 2 Slope (%)	N/A
	X Walk 1 X Slope (%)	3.8		X Walk 2 X Slope (%)	N/A

Possible Solutions:

**Remove & Replace Entire Ramp.**
