Access Compliance Report

Public Rights-of-Way

(Curb Ramps)

Intersection ID: 32254	Main Street: BALLANTYNE_CROSSING_AV	Cross Street: BALLANTYNE_GLEN_WY	Location: W
ADA ID: 9543922F9B76	Ramp Type: Perp	Initial Pass/Fail: Fail	Overall Compliance: No
Severity Score: 13.75			
Codes/Mitigation Info/Possible Solution		Field Measurements/Component Compliance

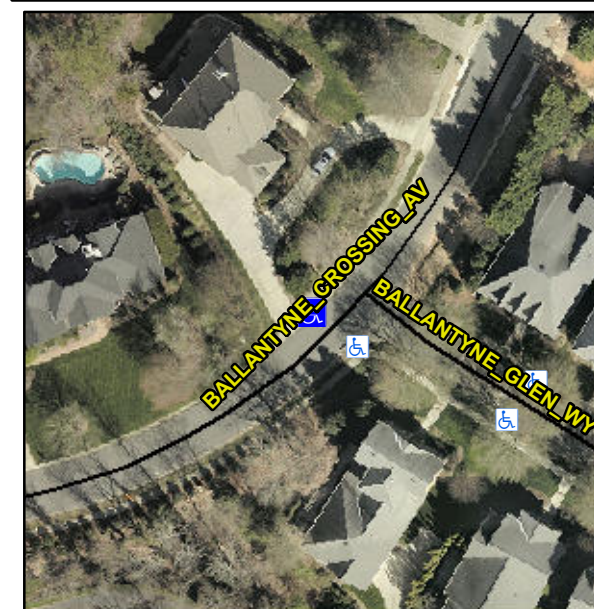
Not Found, R304.2.2, R304.5.3

Compliance	Description	Data	Compliance	Description	Data
N/A	Ramp Length (in)	50.0	No	Ramp Slope (%)	9.2
Yes	Ramp Width (in)	48.0	No	Ramp XSlope (%)	3.9
N/A	Flare Type LT	N/A	N/A	Flare Type RT	N/A
N/A	Flare Slope LT (%)	N/A	N/A	Flare Slope RT (%)	N/A
N/A	Flare Traversable LT?	N/A	N/A	Flare Traversable RT?	N/A
N/A	Landing Length (in)	N/A	N/A	DWS Provided?	N/A
N/A	Landing Width (in)	N/A	N/A	DWS Contrast?	N/A
N/A	Landing Slope (%)	N/A	N/A	DWS Length (in)	N/A
N/A	Landing X Slope (%)	N/A	N/A	DWS Full Width?	N/A
N/A	Landing Curb? (Y/N)	N/A	N/A	DWS Offset (in)	N/A
N/A	Shared Landing?	N/A			
N/A	Gutter Ponding?	N/A	N/A	Gutter Slope (%)	N/A
N/A	Gutter Lip Ht (in)	N/A	N/A	Gutter X Slope (%)	N/A
N/A	Painted X Walk1?	No	N/A	Painted X Walk2?	N/A
	X Walk 1 Direction	To SE		X Walk 2 Direction	N/A
N/A	X Walk 1 Width (in)	N/A	N/A	X Walk 2 Width (in)	N/A
	X Walk 1 Slope (%)	2.4		X Walk 2 Slope (%)	N/A
	X Walk 1 X Slope (%)	0.8		X Walk 2 X Slope (%)	N/A

N/A	Ramp inside XWalk1?	N/A	N/A	Ramp inside XWalk2?	N/A
	Road Slope (%)	N/A	N/A	Clear Space?	N/A
	Road X Slope (%)	N/A	N/A	Clear Space to XWalk (in)	N/A
N/A	Any Obstructions?	N/A	N/A	Storm Grate/Utility Hazard?	N/A
	Obstruction Type			Storm Grate/Utility Type	
		N/A			N/A
			Yes	Surface Condition? (G/P)	Good

Remove & Replace Entire Ramp.
