Access Compliance Report

Public Rights-of-Way

(Curb Ramps)

Intersection ID: 2573	Main Street: CAMBELLTON_DR	Cross Street: PELORUS_LN	Location: NW
ADA ID: 9556E1C3747A	Ramp Type: PerpDiag	Initial Pass/Fail: Fail	Overall Compliance: No
Severity Score: 22.5			
Codes/Mitigation Info/Possible Solution		Field Measurements/Component Compliance

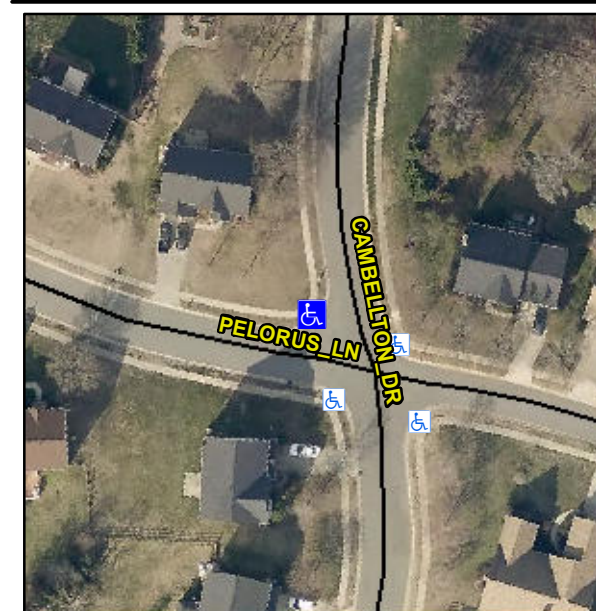
Not Found, R304.5.1, R304.2.2, R304.5.3

Compliance	Description	Data	Compliance	Description	Data
N/A	Ramp Length (in)	46.0	No	Ramp Slope (%)	8.4
No	Ramp Width (in)	41.0	No	Ramp XSlope (%)	3.3
N/A	Flare Type LT	N/A	N/A	Flare Type RT	N/A
N/A	Flare Slope LT (%)	N/A	N/A	Flare Slope RT (%)	N/A
N/A	Flare Traversable LT?	N/A	N/A	Flare Traversable RT?	N/A
N/A	Landing Length (in)	N/A	N/A	DWS Provided?	N/A
N/A	Landing Width (in)	N/A	N/A	DWS Contrast?	N/A
N/A	Landing Slope (%)	N/A	N/A	DWS Length (in)	N/A
N/A	Landing X Slope (%)	N/A	N/A	DWS Full Width?	N/A
N/A	Landing Curb? (Y/N)	N/A	N/A	DWS Offset (in)	N/A
N/A	Shared Landing?	N/A			
N/A	Gutter Ponding?	N/A	N/A	Gutter Slope (%)	N/A
N/A	Gutter Lip Ht (in)	N/A	N/A	Gutter X Slope (%)	N/A
N/A	Painted X Walk1?	No	N/A	Painted X Walk2?	No
	X Walk 1 Direction	To S		X Walk 2 Direction	To E
N/A	X Walk 1 Width (in)	N/A	N/A	X Walk 2 Width (in)	N/A
	X Walk 1 Slope (%)	3.9		X Walk 2 Slope (%)	2.4
	X Walk 1 X Slope (%)	1.5		X Walk 2 X Slope (%)	2.7

N/A	Ramp inside XWalk1?	N/A	N/A	Ramp inside XWalk2?	N/A
	Road Slope (%)	2.0	N/A	Clear Space?	N/A
	Road X Slope (%)	3.5	N/A	Clear Space to XWalk (in)	N/A
N/A	Any Obstructions?	N/A	N/A	Storm Grate/Utility Hazard?	N/A
	Obstruction Type			Storm Grate/Utility Type	
		N/A			N/A
		Yes		Surface Condition? (G/P)	Good

Possible Solutions:

Remove & Replace Curb Ramp With Two New Directional Ramps or Equivalent.
