Access Compliance Report Public Rights-of-Way (Curb Ramps)

Intersection ID: 10019149	Main Street: ATKINS_RIDGE_DR			Cross Street: N/A				Location:	N
ADA ID: 956BE85F98DE	Ramp Type: Perp			Initial Pass/Fail: Fail Overall Compliance: No			o Severity Score:	8.75	
Codes/Mitigation Info/Possible Solution				Field Measurements/Component Compliance					
		Possible Solutions:						liance Description	Data
and the second	1 and	Remove & Replace Entire Ra	mp.	N/A	Ramp Length (in)	47.0	Yes	Ramp Slope (%)	5.6
A Start of a	1/4 On			No	Ramp Width (in)	47.0	Yes	Ramp XSlope (%)	0.7
A A A A A A A A A A A A A A A A A A A	Mar H			N/A	Flare Type LT	N/A	N/A	Flare Type RT	N/A
	1 1			N/A	Flare Slope LT (%)	N/A	N/A	Flare Slope RT (%)	N/A
	1			N/A	Flare Traversable LT?	N/A	N/A	Flare Traversable RT?	N/A
A A A A A A A A A A A A A A A A A A A				N/A	Landing Length (in)	N/A	N/A	DWS Provided?	N/A
	ISTAN O	Surveyor Notes:		N/A	Landing Width (in)	N/A	N/A	DWS Contrast?	N/A
the second se	- COD	N/A		N/A	Landing Slope (%)	N/A	N/A	DWS Length (in)	N/A

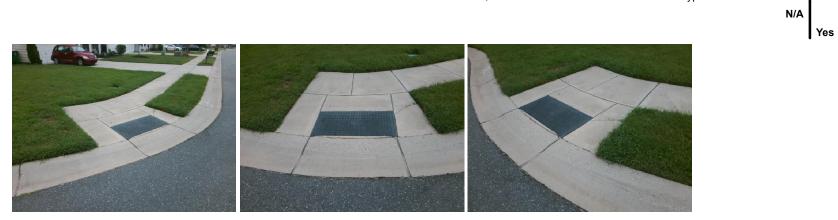
b. b.				N/A	Landing X Slope (%)	N/A	N/A	DWS Full Width?	N/A
	The second			N/A	Landing Curb? (Y/N)	N/A	N/A	DWS Offset (in)	N/A
	1-1-1			N/A	Shared Landing?	N/A			
148		PROW/ADA:		N/A	Gutter Ponding?	N/A	N/A	Gutter Slope (%)	N/A
		Not Found, R304.5.1		N/A	Gutter Lip Ht (in)	N/A	N/A	Gutter X Slope (%)	N/A
the state of the state				N/A	Painted X Walk1?	No	N/A	Painted X Walk2?	N/A

A. ASTONIC CONT	the way				X Walk 1 Direction	To SE		X Walk 2 Direction	N/A
	Ser Star			N/A	X Walk 1 Width (in)	N/A	N/A	X Walk 2 Width (in)	N/A
Street 1 Name ATKIN	S RIDGE DR	_			X Walk 1 Slope (%)	6.3		X Walk 2 Slope (%)	N/A
Stop Condition-Street 2	None				X Walk 1 X Slope (%)	2.5		X Walk 2 X Slope (%)	N/A
Street 2 Name	N/A			N/A	Ramp inside XWalk1?	N/A	N/A	Ramp inside XWalk2?	N/A
Stop Condition-Street 1	N/A				Road Slope (%)	N/A	N/A	Clear Space?	N/A
					Road X Slope (%)	N/A	N/A	Clear Space to XWalk (in)	N/A
				N/A	Any Obstructions?	N/A	N/A	Storm Grate/Utility Hazard?	N/A
		Total Cost: \$	1850.00		Obstruction Type			Storm Grate/Utility Type	
						N/A			N/A
