Access Compliance Report

Public Rights-of-Way

(Curb Ramps)

Intersection ID: 30170	Main Street: BIESTERFIELD_DR	Cross Street: SLATER_RIDGE_DR	Location:	N
ADA ID: 956EED6F92DC	Ramp Type: PerpDiag	Initial Pass/Fail: Fail	Overall Compliance: No	Severity Score: 46.25

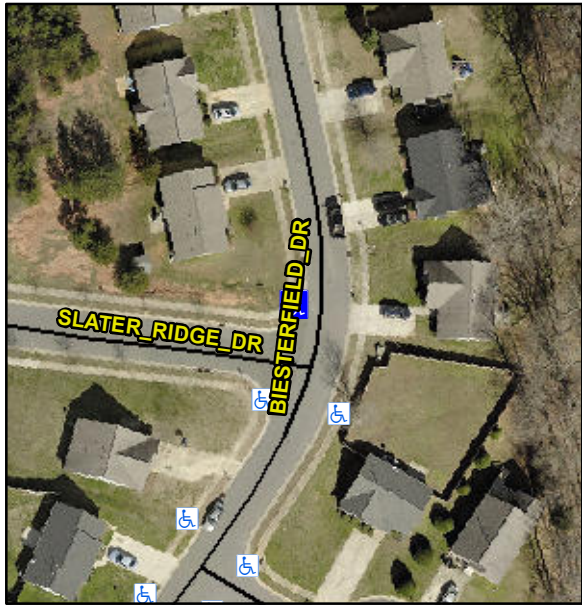
Surveyor Notes:		N/A	N/A	Landing Curb? (Y/N)	N/A	N/A	DWS Offset (in)	N/A
PROW/ADA:		Not Found, R304.5.1, R304.2.2, R304.5.3	N/A	Shared Landing?	N/A			
			N/A	Gutter Ponding?	N/A	N/A	Gutter Slope (%)	N/A
			N/A	Gutter Lip Ht (in)	N/A	N/A	Gutter X Slope (%)	N/A
			N/A	Painted X Walk1?	No	N/A	Painted X Walk2?	No
				X Walk 1 Direction	To S		X Walk 2 Direction	To E
			N/A	X Walk 1 Width (in)	N/A	N/A	X Walk 2 Width (in)	N/A
				X Walk 1 Slope (%)	6.4		X Walk 2 Slope (%)	1.1
				X Walk 1 X Slope (%)	0.5		X Walk 2 X Slope (%)	5.6
			N/A	Ramp inside XWalk1?	N/A	N/A	Ramp inside XWalk2?	N/A
				Road Slope (%)	5.7	N/A	Clear Space?	N/A
				Road X Slope (%)	6.5	N/A	Clear Space to XWalk (in)	N/A
			N/A	Any Obstructions?	N/A	N/A	Storm Grate/Utility Hazard?	N/A
				Obstruction Type			Storm Grate/Utility Type	
					N/A			N/A
						Yes	Surface Condition? (G/P)	Good
Total Cost:		\$ 3200.00

<div>Street 1 Name<div>BLISTERFIELD DR</div></div> <div>Stop Condition-Street 2<div>StopSign</div></div> <div>Street 2 Name<div>SLATERFIELD DR</div></div> <div>Stop Condition-Street 1<div>None</div></div>	Possible Solutions:		Compliance	Description	Data	Compliance	Description	Data
	Remove & Replace Curb Ramp With Two New Directional Ramps or Equivalent.		N/A	Ramp Length (in)	46.0	No	Ramp Slope (%)	8.4
			No	Ramp Width (in)	46.5	No	Ramp XSlope (%)	10.4
			N/A	Flare Type LT	N/A	N/A	Flare Type RT	N/A
			N/A	Flare Slope LT (%)	N/A	N/A	Flare Slope RT (%)	N/A
			N/A	Flare Traversable LT?	N/A	N/A	Flare Traversable RT?	N/A
			N/A	Landing Length (in)	N/A	N/A	DWS Provided?	N/A
			N/A	Landing Width (in)	N/A	N/A	DWS Contrast?	N/A
			N/A	Landing Slope (%)	N/A	N/A	DWS Length (in)	N/A
			N/A	Landing X Slope (%)	N/A	N/A	DWS Full Width?	N/A
