## **Access Compliance Report Public Rights-of-Way** (Curb Ramps)

Intersection ID: 9076 Main Street: STATESVILLE AV Cross Street: MORETZ\_AV Location: NW **Overall Compliance: No** ADA ID: 957867EB9F5B Ramp Type: BlendTrans1 Initial Pass/Fail: Fail **Severity Score:** 8.75

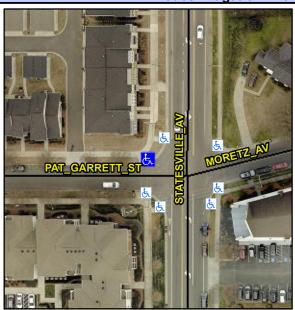
| Comp | liance Description | Data | Comp | liance Description | Data |
|---|---|---|---|---|---|
| No | Ramp Width (in) | 45.0 | Yes | BlendTrans XSlope (%) | 1.8 |

**Two New Directional Ramps or** Equivalent. Surveyor Notes: N/A

**Remove & Replace Curb Ramp With**

R304.5.1
