# Access Compliance Report

## Public Rights-of-Way

### (Curb Ramps)

Intersection ID: 3250	Main Street: BILLINGHAM_DR	Cross Street: HIGHCROFT_LN	Location:	E
ADA ID: 957996D1A374	Ramp Type: Perp	Initial Pass/Fail: Fail	Overall Compliance: No	Severity Score: 12.5

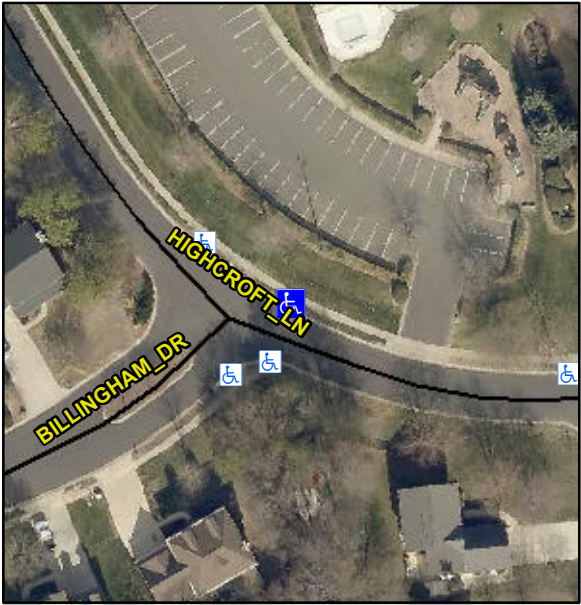
Possible Solutions:		<b>Compliance</b>	<b>Description</b>	<b>Data</b>
	<b>Remove &amp; Replace Entire Ramp.</b>		<b>No</b>	Ramp Length (in)	48.0
			<b>Yes</b>	Ramp Width (in)	48.0
			<b>N/A</b>	Flare Type LT	N/A
			<b>N/A</b>	Flare Slope LT (%)	N/A
			<b>N/A</b>	Flare Traversable LT?	N/A
			<b>N/A</b>	Landing Length (in)	N/A
			<b>N/A</b>	Landing Width (in)	N/A
			<b>N/A</b>	Landing Slope (%)	N/A
			<b>N/A</b>	Landing X Slope (%)	N/A
<p>Surveyor Notes:</p> <p><b>N/A</b></p> <p>PROW/ADA:</p> <p><b>Not Found, R304.2.2</b></p>			<b>N/A</b>	Flare Type RT	N/A
			<b>N/A</b>	Flare Slope RT (%)	N/A
			<b>N/A</b>	Flare Traversable RT?	N/A
			<b>N/A</b>	DWS Provided?	N/A
			<b>N/A</b>	DWS Contrast?	N/A
			<b>N/A</b>	DWS Length (in)	N/A
			<b>N/A</b>	DWS Full Width?	N/A
			<b>N/A</b>	DWS Offset (in)	N/A
			<b>N/A</b>	Shared Landing?	N/A

<b>N/A</b>	Gutter Ponding?	N/A
			<b>N/A</b>	Gutter Lip Ht (in)	N/A
			<b>No</b>	Painted X Walk1?	N/A
				X Walk 1 Direction	To SW
			<b>N/A</b>	X Walk 1 Width (in)	N/A
				X Walk 1 Slope (%)	5.6
				X Walk 1 X Slope (%)	2.5
			<b>N/A</b>	Ramp inside XWalk1?	N/A
			<b>N/A</b>	Ramp inside XWalk2?	N/A
			<b>N/A</b>	Road Slope (%)	N/A
			<b>N/A</b>	Road X Slope (%)	N/A
			<b>N/A</b>	Any Obstructions?	N/A
				Obstruction Type	
			<b>N/A</b>		
			<b>N/A</b>		
			<b>N/A</b>		
			<b>N/A</b>		
			<b>N/A</b>		
			<b>N/A</b>		
			<b>N/A</b>		
			<b>N/A</b>		
			<b>Yes</b>	Surface Condition? (G/P)	Good
