# Access Compliance Report

## Public Rights-of-Way

### (Curb Ramps)

| Intersection ID: 28344 | Main Street: BELLHAVEN_WALK_CT | Cross Street: BRIDGEHAMPTON_CLUB_DR | Location: SW |

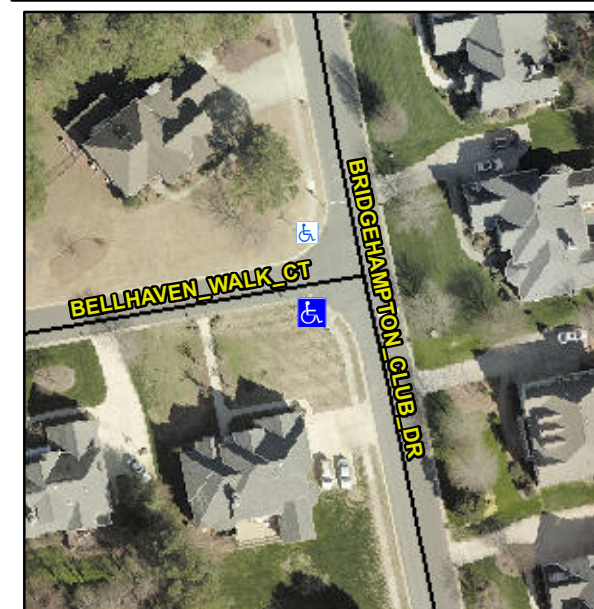
**Not Found, R304.5.1, R304.2.2**

| Compliance | Description | Data | Compliance | Description | Data |
|---|---|---|---|---|---|
| N/A | Ramp Length (in) | 49.0 | No | Ramp Slope (%) | 9.5 |
| No | Ramp Width (in) | 41.0 | Yes | Ramp XSlope (%) | 0.1 |

**Remove & Replace Entire Ramp.**
