## **Access Compliance Report Public Rights-of-Way** (Curb Ramps)

Intersection ID: 32273 Main Street: GREYMORE CT **Cross Street: PRESCOTT HILL AV** S Location:

**Overall Compliance: No Severity Score:** 10 ADA ID: 95982E73AEC7 Ramp Type: PerpDiag Initial Pass/Fail: Fail

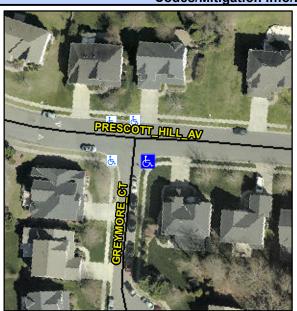
Compliance Description Data Compliance Description Yes N/A Ramp Length (in) 46.0 Ramp Slope (%) No Ramp XSlope (%) No Ramp Width (in) 36.0 N/A Flare Type LT N/A N/A Flare Type RT N/A N/A Flare Slope RT (%) Flare Slope LT (%) N/A N/A Flare Traversable LT? N/A N/A Flare Traversable RT? N/A N/A N/A **DWS Provided?** Landing Length (in) N/A Landing Width (in) N/A N/A **DWS Contrast?** N/A N/A Landing Slope (%) N/A DWS Length (in) N/A Landing X Slope (%) N/A N/A DWS Full Width? N/A Landing Curb? (Y/N) N/A N/A DWS Offset (in) N/A N/A Shared Landing? N/A **Gutter Ponding?** N/A N/A Gutter Slope (%) N/A Gutter Lip Ht (in) N/A N/A Gutter X Slope (%) N/A Painted X Walk1? No N/A Painted X Walk2? X Walk 1 Direction To N X Walk 2 Direction N/A N/A X Walk 1 Width (in) X Walk 2 Width (in) X Walk 1 Slope (%) X Walk 2 Slope (%) 1.8 X Walk 1 X Slope (%) 5.2 X Walk 2 X Slope (%) N/A N/A N/A Ramp inside XWalk2? Ramp inside XWalk1? Road Slope (%) 1.6 N/A Clear Space? N/A Road X Slope (%) 4.6 Clear Space to XWalk (in) N/A N/A N/A Any Obstructions? Storm Grate/Utility Hazard?

PRESCOTT HILL AV Street 1 Name Stop Condition-Street 2 None **GREYMORE CT** Street 2 Name Stop Condition-Street 1 StopSign Possible Solutions: Remove & Replace Curb Ramp With Two New Directional Ramps or Equivalent. Surveyor Notes: N/A PROW/ADA: Not Found, R304.5.1, R304.5.3
