# Access Compliance Report

## Public Rights-of-Way

### (Curb Ramps)

Intersection ID: 10353	Main Street: E_35TH_ST	Cross Street: N_MCDOWELL_ST	Location: W
ADA ID: 959BC8EE9451	Ramp Type: PerpDiag	Initial Pass/Fail: Fail	Overall Compliance: No
		Severity Score: 25

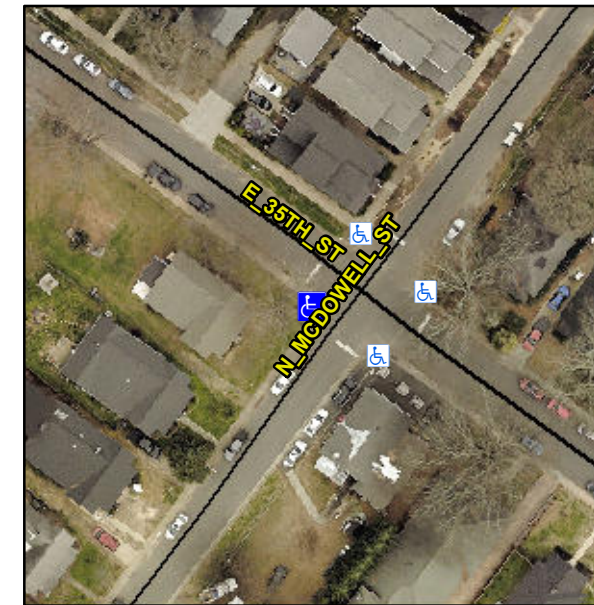
**Not Found, R304.2.2**

Compliance	Description	Data	Compliance	Description	Data
N/A	Ramp Length (in)	56.0	No	Ramp Slope (%)	12.9
Yes	Ramp Width (in)	52.0	Yes	Ramp XSlope (%)	0.4
N/A	Flare Type LT	N/A	N/A	Flare Type RT	N/A
N/A	Flare Slope LT (%)	N/A	N/A	Flare Slope RT (%)	N/A
N/A	Flare Traversable LT?	N/A	N/A	Flare Traversable RT?	N/A
N/A	Landing Length (in)	N/A	N/A	DWS Provided?	N/A
N/A	Landing Width (in)	N/A	N/A	DWS Contrast?	N/A
N/A	Landing Slope (%)	N/A	N/A	DWS Length (in)	N/A
N/A	Landing X Slope (%)	N/A	N/A	DWS Full Width?	N/A
N/A	Landing Curb? (Y/N)	N/A	N/A	DWS Offset (in)	N/A
N/A	Shared Landing?	N/A			
N/A	Gutter Ponding?	N/A	N/A	Gutter Slope (%)	N/A
N/A	Gutter Lip Ht (in)	N/A	N/A	Gutter X Slope (%)	N/A
N/A	Painted X Walk1?	No	N/A	Painted X Walk2?	No
	X Walk 1 Direction	To SE		X Walk 2 Direction	To NE
N/A	X Walk 1 Width (in)	N/A	N/A	X Walk 2 Width (in)	N/A
	X Walk 1 Slope (%)	0.6		X Walk 2 Slope (%)	4.4
	X Walk 1 X Slope (%)	1.9		X Walk 2 X Slope (%)	1.3

N/A	Ramp inside XWalk1?	N/A	N/A	Ramp inside XWalk2?	N/A
	Road Slope (%)	2.8	N/A	Clear Space?	N/A
	Road X Slope (%)	4.7	N/A	Clear Space to XWalk (in)	N/A
N/A	Any Obstructions?	N/A	N/A	Storm Grate/Utility Hazard?	N/A
	Obstruction Type			Storm Grate/Utility Type	
		N/A			N/A
			Yes	Surface Condition? (G/P)	Good

**Remove & Replace Curb Ramp With Two New Directional Ramps or Equivalent.**
