Access Compliance Report

Public Rights-of-Way

(Curb Ramps)

Intersection ID: 14679	Main Street: MCMANUS_DR	Cross Street: WINTERFIELD_PL	Location: SW
ADA ID: 95A55AD7E1CA	Ramp Type: Perp	Initial Pass/Fail: Fail	Overall Compliance: No
Severity Score: 10			
Codes/Mitigation Info/Possible Solution		Field Measurements/Component Compliance

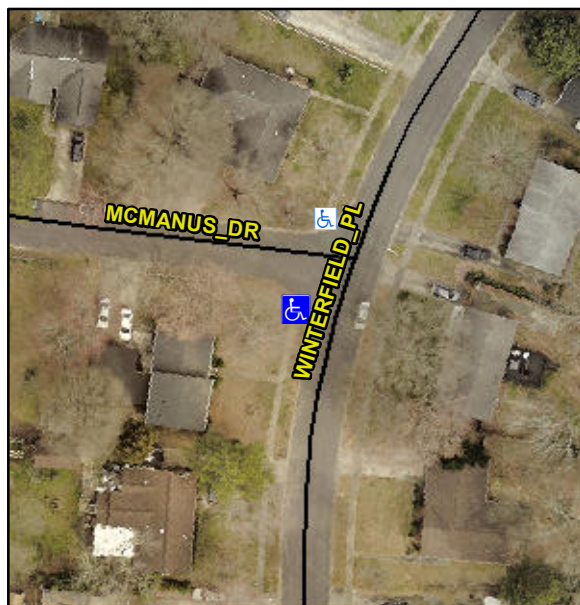
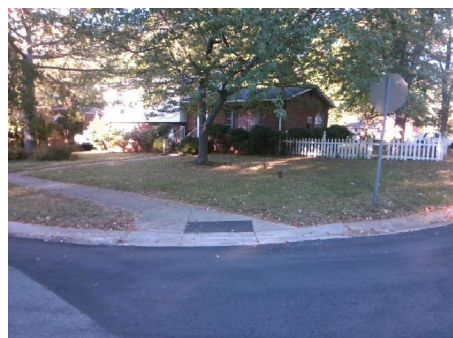
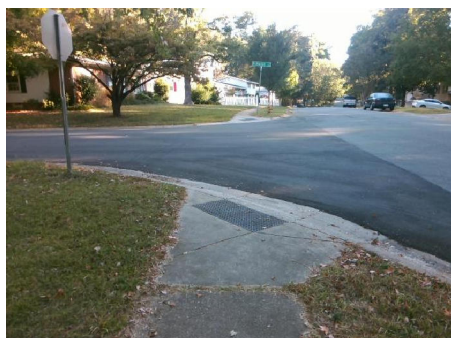
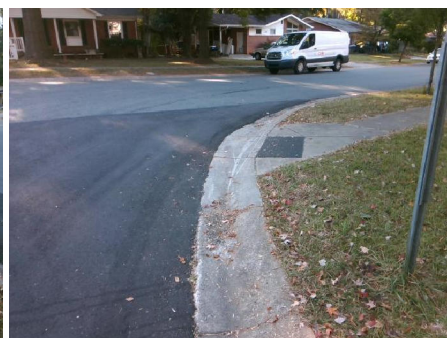
Not Found, R304.5.1, R304.5.3

Compliance	Description	Data	Compliance	Description	Data
N/A	Ramp Length (in)	33.0	Yes	Ramp Slope (%)	6.3
No	Ramp Width (in)	47.5	No	Ramp XSlope (%)	3.0
N/A	Flare Type LT	N/A	N/A	Flare Type RT	N/A
N/A	Flare Slope LT (%)	N/A	N/A	Flare Slope RT (%)	N/A
N/A	Flare Traversable LT?	N/A	N/A	Flare Traversable RT?	N/A
N/A	Landing Length (in)	N/A	N/A	DWS Provided?	N/A
N/A	Landing Width (in)	N/A	N/A	DWS Contrast?	N/A
N/A	Landing Slope (%)	N/A	N/A	DWS Length (in)	N/A
N/A	Landing X Slope (%)	N/A	N/A	DWS Full Width?	N/A
N/A	Landing Curb? (Y/N)	N/A	N/A	DWS Offset (in)	N/A
N/A	Shared Landing?	N/A			
N/A	Gutter Ponding?	N/A	N/A	Gutter Slope (%)	N/A
N/A	Gutter Lip Ht (in)	N/A	N/A	Gutter X Slope (%)	N/A
N/A	Painted X Walk1?	No	N/A	Painted X Walk2?	N/A
	X Walk 1 Direction	To NE		X Walk 2 Direction	N/A
N/A	X Walk 1 Width (in)	N/A	N/A	X Walk 2 Width (in)	N/A
	X Walk 1 Slope (%)	5.3		X Walk 2 Slope (%)	N/A
	X Walk 1 X Slope (%)	2.3		X Walk 2 X Slope (%)	N/A

N/A	Ramp inside XWalk1?	N/A	N/A	Ramp inside XWalk2?	N/A
	Road Slope (%)	N/A	N/A	Clear Space?	N/A
	Road X Slope (%)	N/A	N/A	Clear Space to XWalk (in)	N/A
N/A	Any Obstructions?	N/A	N/A	Storm Grate/Utility Hazard?	N/A
	Obstruction Type			Storm Grate/Utility Type	
		N/A			N/A
			Yes	Surface Condition? (G/P)	Good

Possible Solutions:

Remove & Replace Entire Ramp.
