Access Compliance Report

Public Rights-of-Way

(Curb Ramps)

Intersection ID: 12516	Main Street: ARTY_AV	Cross Street: W_MOREHEAD_ST	Location:	N
ADA ID: 95C0F944EAA5	Ramp Type: Perp	Initial Pass/Fail: Fail	Overall Compliance: No	Severity Score: 10

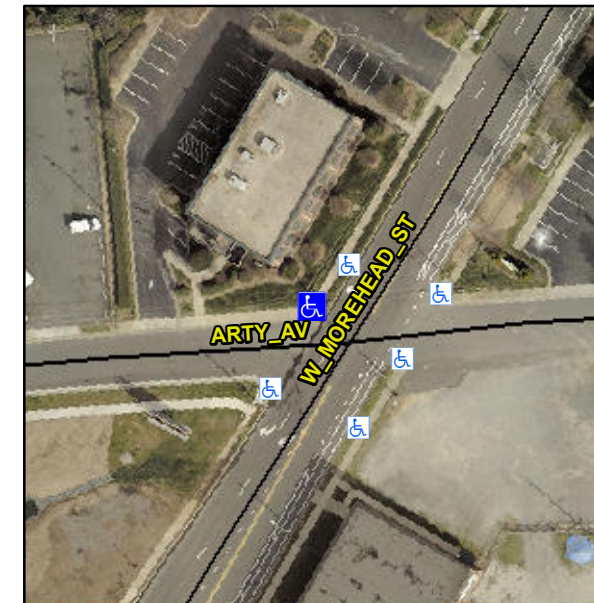
Not Found, R304.5.1, R304.5.3

Compliance	Description	Data	Compliance	Description	Data
N/A	Ramp Length (in)	61.0	Yes	Ramp Slope (%)	6.1
No	Ramp Width (in)	47.0	No	Ramp XSlope (%)	3.3
N/A	Flare Type LT	N/A	N/A	Flare Type RT	N/A
N/A	Flare Slope LT (%)	N/A	N/A	Flare Slope RT (%)	N/A
N/A	Flare Traversable LT?	N/A	N/A	Flare Traversable RT?	N/A
N/A	Landing Length (in)	N/A	N/A	DWS Provided?	N/A
N/A	Landing Width (in)	N/A	N/A	DWS Contrast?	N/A
N/A	Landing Slope (%)	N/A	N/A	DWS Length (in)	N/A
N/A	Landing X Slope (%)	N/A	N/A	DWS Full Width?	N/A
N/A	Landing Curb? (Y/N)	N/A	N/A	DWS Offset (in)	N/A
N/A	Shared Landing?	N/A			
N/A	Gutter Ponding?	N/A	N/A	Gutter Slope (%)	N/A
N/A	Gutter Lip Ht (in)	N/A	N/A	Gutter X Slope (%)	N/A
N/A	Painted X Walk1?	No	N/A	Painted X Walk2?	N/A
	X Walk 1 Direction	To SW		X Walk 2 Direction	N/A
N/A	X Walk 1 Width (in)	N/A	N/A	X Walk 2 Width (in)	N/A
	X Walk 1 Slope (%)	1.8		X Walk 2 Slope (%)	N/A
	X Walk 1 X Slope (%)	4.6		X Walk 2 X Slope (%)	N/A

N/A	Ramp inside XWalk1?	N/A	N/A	Ramp inside XWalk2?	N/A
	Road Slope (%)	N/A	N/A	Clear Space?	N/A
	Road X Slope (%)	N/A	N/A	Clear Space to XWalk (in)	N/A
N/A	Any Obstructions?	N/A	N/A	Storm Grate/Utility Hazard?	N/A
	Obstruction Type			Storm Grate/Utility Type	
		N/A			N/A
			Yes	Surface Condition? (G/P)	Good

Possible Solutions:

Remove & Replace Entire Ramp.
