Access Compliance Report

Public Rights-of-Way

(Curb Ramps)

Intersection ID: N/A	Main Street: WALNUT_LOOP_RD	Cross Street: WOODBINE_WALK_RD	Location: SW
ADA ID: 95C43768E96C	Ramp Type: Perp	Initial Pass/Fail: Fail	Overall Compliance: No
Severity Score: 13.75			
Codes/Mitigation Info/Possible Solution		Field Measurements/Component Compliance

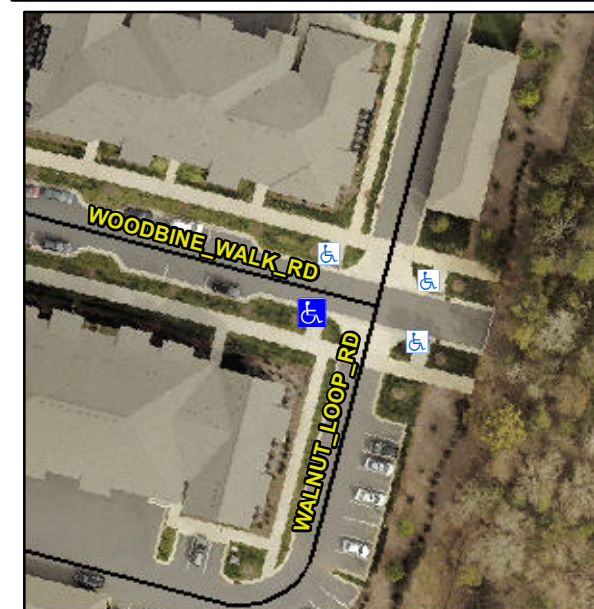
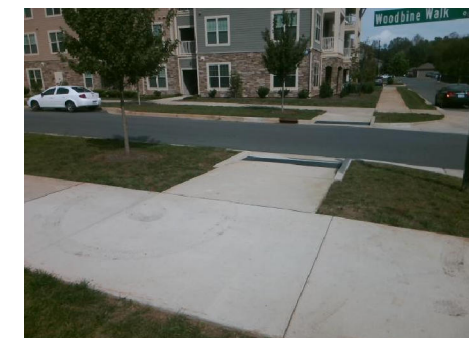
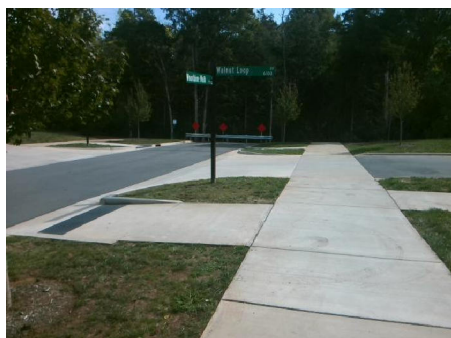
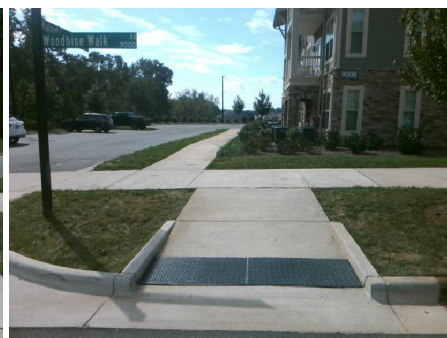
Not Found, R304.2.2, R304.5.3

Compliance	Description	Data	Compliance	Description	Data
N/A	Ramp Length (in)	72.0	No	Ramp Slope (%)	8.5
Yes	Ramp Width (in)	94.0	No	Ramp XSlope (%)	3.7
N/A	Flare Type LT	N/A	N/A	Flare Type RT	N/A
N/A	Flare Slope LT (%)	N/A	N/A	Flare Slope RT (%)	N/A
N/A	Flare Traversable LT?	N/A	N/A	Flare Traversable RT?	N/A
N/A	Landing Length (in)	N/A	N/A	DWS Provided?	N/A
N/A	Landing Width (in)	N/A	N/A	DWS Contrast?	N/A
N/A	Landing Slope (%)	N/A	N/A	DWS Length (in)	N/A
N/A	Landing X Slope (%)	N/A	N/A	DWS Full Width?	N/A
N/A	Landing Curb? (Y/N)	N/A	N/A	DWS Offset (in)	N/A
N/A	Shared Landing?	N/A			
N/A	Gutter Ponding?	N/A	N/A	Gutter Slope (%)	N/A
N/A	Gutter Lip Ht (in)	N/A	N/A	Gutter X Slope (%)	N/A
N/A	Painted X Walk1?	No	N/A	Painted X Walk2?	N/A
	X Walk 1 Direction	To NE		X Walk 2 Direction	N/A
N/A	X Walk 1 Width (in)	N/A	N/A	X Walk 2 Width (in)	N/A
	X Walk 1 Slope (%)	1.2		X Walk 2 Slope (%)	N/A
	X Walk 1 X Slope (%)	1.8		X Walk 2 X Slope (%)	N/A

N/A	Ramp inside XWalk1?	N/A	N/A	Ramp inside XWalk2?	N/A
	Road Slope (%)	N/A	N/A	Clear Space?	N/A
	Road X Slope (%)	N/A	N/A	Clear Space to XWalk (in)	N/A
N/A	Any Obstructions?	N/A	N/A	Storm Grate/Utility Hazard?	N/A
	Obstruction Type			Storm Grate/Utility Type	
		N/A			N/A
			Yes	Surface Condition? (G/P)	Good

Remove & Replace Entire Ramp.
