# Access Compliance Report

## Public Rights-of-Way

### (Curb Ramps)

| Intersection ID: 13535 | Main Street: SAM_RYBURN_WALK | Cross Street: CHARLOTTETOWNE_AV | Location: S |

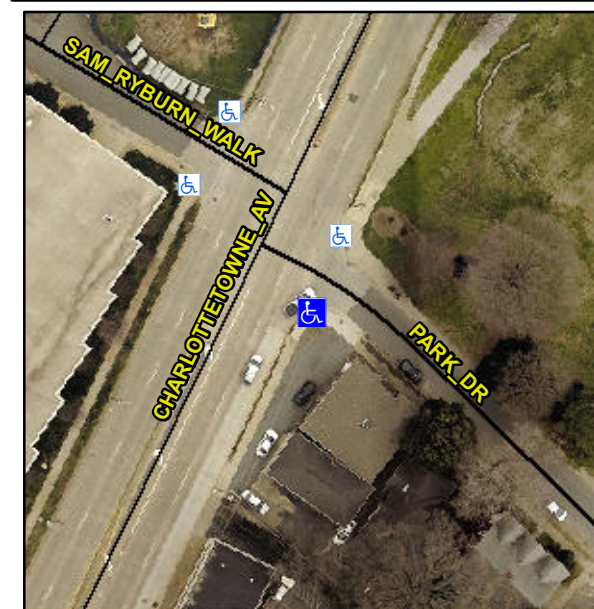
| ADA ID: 95CCB1B734D1 | Ramp Type: PerpDiag | Initial Pass/Fail: Fail | Overall Compliance: No |
| Severity Score: 13.75 | | | |

**Not Found, R304.2.2, R304.5.3**

| Compliance | Description | Data | Compliance | Description | Data |
|---|---|---|---|---|---|
| N/A | Ramp Length (in) | 59.0 | No | Ramp Slope (%) | 11.4 |
| Yes | Ramp Width (in) | 50.0 | No | Ramp XSlope (%) | 5.0 |

**Remove & Replace Curb Ramp With Two New Directional Ramps or Equivalent.**
