# Access Compliance Report

## Public Rights-of-Way

### (Curb Ramps)

Intersection ID: N/A	Main Street: PENCE_RD	Cross Street: PARKERS_CROSSING_DR	Location: NE
ADA ID: 95D18C20FAD8	Ramp Type: Combination2	Initial Pass/Fail: Fail	Overall Compliance: No
		Severity Score: 22.5

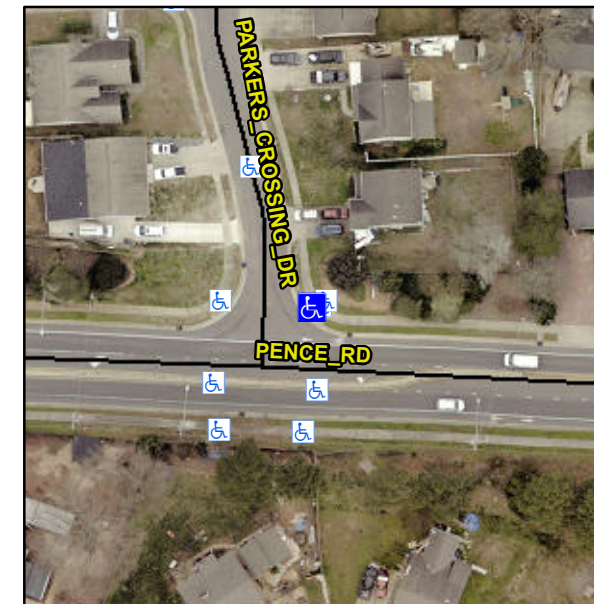
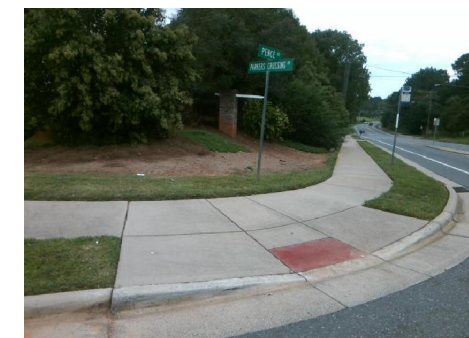
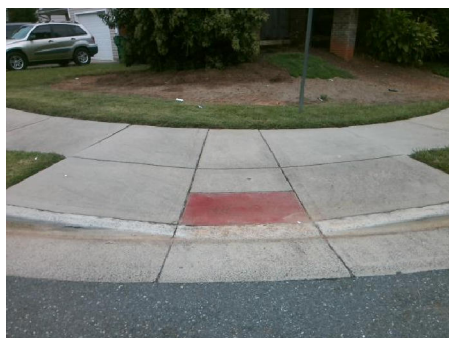
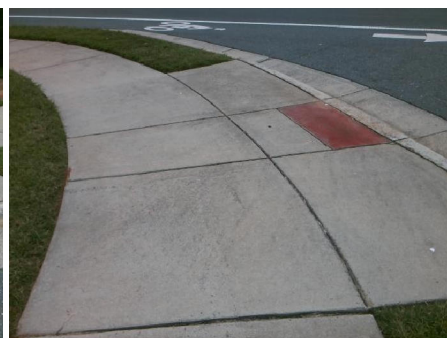
**R304.5.1, R304.5.3, R304.3.2**

Compliance	Description	Data	Compliance	Description	Data
N/A	Ramp Length LT (in)	48.0	N/A	Ramp Length RT (in)	N/A
Yes	Ramp Width LT (in)	60.0	N/A	Ramp Width RT (in)	N/A
No	Ramp Slope LT (%)	8.4	N/A	Ramp Slope RT (%)	N/A
No	Ramp XSlope LT (%)	4.5	N/A	Ramp XSlope RT (%)	N/A
N/A	Ramp Length (in)	47.5	Yes	Ramp Slope (%)	5.6
No	Ramp Width (in)	39.0	No	Ramp XSlope (%)	2.9
N/A	Flare Type LT	N/A	N/A	Flare Type RT	N/A
N/A	Flare Slope LT (%)	N/A	N/A	Flare Slope RT (%)	N/A
N/A	Flare Traversable LT?	N/A	N/A	Flare Traversable RT?	N/A
N/A	Landing Length (in)	N/A	N/A	DWS Provided?	N/A
N/A	Landing Width (in)	N/A	N/A	DWS Contrast?	N/A
N/A	Landing Slope (%)	N/A	N/A	DWS Length (in)	N/A
N/A	Landing X Slope (%)	N/A	N/A	DWS Full Width?	N/A
N/A	Landing Curb? (Y/N)	N/A	N/A	DWS Offset (in)	N/A
N/A	Shared Landing?	N/A			
N/A	Gutter Ponding?	N/A	N/A	Gutter Slope (%)	N/A
N/A	Gutter Lip Ht (in)	N/A	N/A	Gutter X Slope (%)	N/A
N/A	Painted X Walk1?	No	N/A	Painted X Walk2?	No

X Walk 1 Direction	To W		X Walk 2 Direction	To S
	X Walk 1 Width (in)	N/A		X Walk 2 Width (in)	N/A
	X Walk 1 Slope (%)	5.9		X Walk 2 Slope (%)	1.9
	X Walk 1 X Slope (%)	2.5		X Walk 2 X Slope (%)	5.0
N/A	Ramp inside XWalk1?	N/A	N/A	Ramp inside XWalk2?	N/A
	Road Slope (%)	3.1		Clear Space?	N/A
	Road X Slope (%)	3.7	N/A	Clear Space to XWalk (in)	N/A
			N/A	Any Obstruction?	N/A
				Obstruction Type	N/A
			N/A	Storm Grate/Utility Hazard?	N/A
				Storm Grate/Utility Type	N/A
			Yes	Surface Condition? (G/P)	Good
				Curb Slope (%)	4.6

**Remove & Replace Entire Ramp.**
