Access Compliance Report

Public Rights-of-Way

(Curb Ramps)

Intersection ID: 51075	Main Street: MORTEMER_LN	Cross Street: SILVER_GLEN_LN	Location: SE
ADA ID: 95EDBF7EC70B	Ramp Type: PerpDiag	Initial Pass/Fail: Fail	Overall Compliance: No
Codes/Mitigation Info/Possible Solution		Field Measurements/Component Compliance	
Severity Score: 58.75

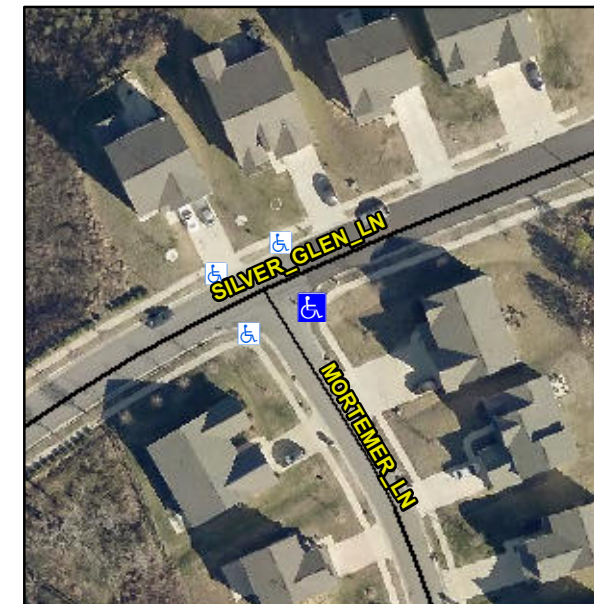
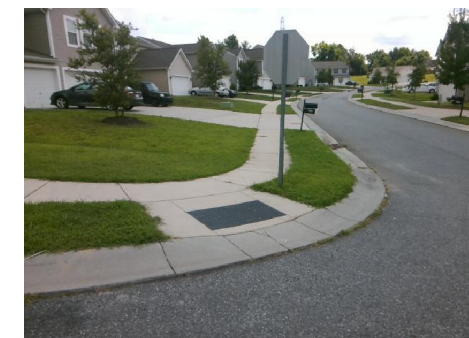
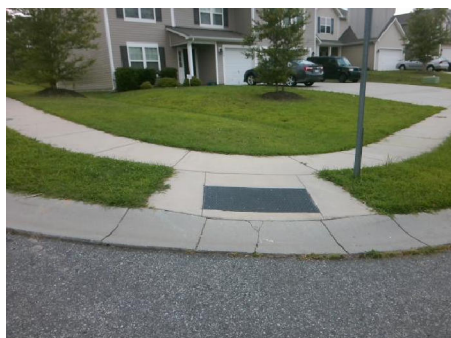
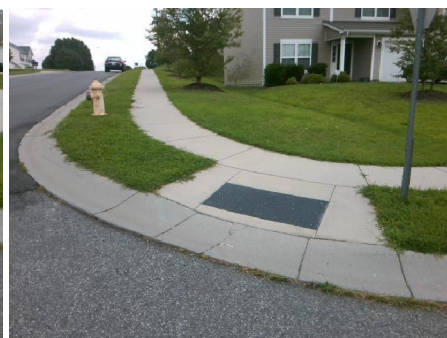
Not Found, R304.5.1, R304.2.2, R304.5.3

Compliance	Description	Data	Compliance	Description	Data
N/A	Ramp Length (in)	49.0	No	Ramp Slope (%)	13.5
No	Ramp Width (in)	44.0	No	Ramp XSlope (%)	9.2
N/A	Flare Type LT	N/A	N/A	Flare Type RT	N/A
N/A	Flare Slope LT (%)	N/A	N/A	Flare Slope RT (%)	N/A
N/A	Flare Traversable LT?	N/A	N/A	Flare Traversable RT?	N/A
N/A	Landing Length (in)	N/A	N/A	DWS Provided?	N/A
N/A	Landing Width (in)	N/A	N/A	DWS Contrast?	N/A
N/A	Landing Slope (%)	N/A	N/A	DWS Length (in)	N/A
N/A	Landing X Slope (%)	N/A	N/A	DWS Full Width?	N/A
N/A	Landing Curb? (Y/N)	N/A	N/A	DWS Offset (in)	N/A
N/A	Shared Landing?	N/A			
N/A	Gutter Ponding?	N/A	N/A	Gutter Slope (%)	N/A
N/A	Gutter Lip Ht (in)	2.0	N/A	Gutter X Slope (%)	N/A
N/A	Painted X Walk1?	No	N/A	Painted X Walk2?	No
	X Walk 1 Direction	To N		X Walk 2 Direction	To W
N/A	X Walk 1 Width (in)	N/A	N/A	X Walk 2 Width (in)	N/A
	X Walk 1 Slope (%)	1.8		X Walk 2 Slope (%)	5.3
	X Walk 1 X Slope (%)	9.1		X Walk 2 X Slope (%)	4.7

N/A	Ramp inside XWalk1?	N/A	N/A	Ramp inside XWalk2?	N/A
	Road Slope (%)	10.3	N/A	Clear Space?	N/A
	Road X Slope (%)	4.2	N/A	Clear Space to XWalk (in)	N/A
N/A	Any Obstructions?	N/A	N/A	Storm Grate/Utility Hazard?	N/A
	Obstruction Type			Storm Grate/Utility Type	
		N/A			N/A
			Yes	Surface Condition? (G/P)	Good

Remove & Replace Curb Ramp With Two New Directional Ramps or Equivalent.
