Access Compliance Report

Public Rights-of-Way

(Curb Ramps)

Intersection ID: 14252	Main Street: BAXTER_ST	Cross Street: CECIL_ST	Location: NW
ADA ID: 95F2EEB38569	Ramp Type: BlendTrans1	Initial Pass/Fail: Fail	Overall Compliance: No
		Severity Score: 12.5

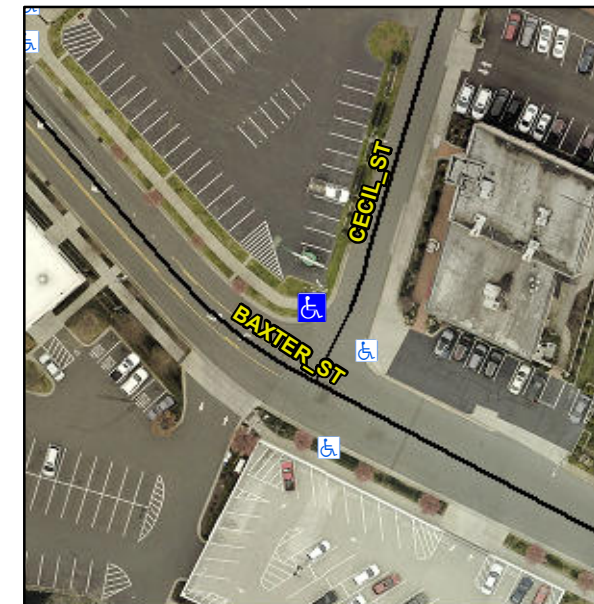
Compliance	Description	Data	Compliance	Description	Data
N/A	Ramp Length (in)	51.0	Yes	BlendTrans Slope (%)	3.4
Yes	Ramp Width (in)	48.0	No	BlendTrans XSlope (%)	6.1
N/A	Flare Type LT	N/A	N/A	Flare Type RT	N/A
N/A	Flare Slope LT (%)	N/A	N/A	Flare Slope RT (%)	N/A
N/A	Flare Traversable LT?	N/A	N/A	Flare Traversable RT?	N/A
N/A	Landing Length (in)	N/A	N/A	DWS Provided?	N/A
N/A	Landing Width (in)	N/A	N/A	DWS Contrast?	N/A
N/A	Landing Slope (%)	N/A	N/A	DWS Length (in)	N/A
N/A	Landing X Slope (%)	N/A	N/A	DWS Full Width?	N/A
N/A	Landing Curb? (Y/N)	N/A	N/A	DWS Offset (in)	N/A
N/A	Shared Landing?	N/A			
N/A	Gutter Ponding?	N/A	N/A	Gutter Slope (%)	N/A
N/A	Gutter Lip Ht (in)	N/A	N/A	Gutter X Slope (%)	N/A
N/A	Painted X Walk1?	No	N/A	Painted X Walk2?	No
	X Walk 1 Direction	To SW		X Walk 2 Direction	To SE
	X Walk 1 Width (in)	N/A		X Walk 2 Width (in)	N/A
	X Walk 1 Slope (%)	1.3		X Walk 2 Slope (%)	6.9
	X Walk 1 X Slope (%)	8.7		X Walk 2 X Slope (%)	0.5

N/A	Ramp inside XWalk1?	N/A	N/A	Ramp inside XWalk2?	N/A
	Road Slope (%)	5.8		Clear Space?	N/A
	Road X Slope (%)	5.5	N/A	Clear Space to XWalk (in)	N/A
N/A	Any Obstructions?	N/A	N/A	Storm Grate/Utility Hazard?	N/A
	Obstruction Type			Storm Grate/Utility Type	
		N/A			N/A
			Yes	Surface Condition? (G/P)	Good
			N/A	Curb Slope (%)	2.3

Possible Solutions:

Remove & Replace Curb Ramp With Two New Directional Ramps or Equivalent.

R304.5.3
