## **Access Compliance Report Public Rights-of-Way** (Curb Ramps)

Intersection ID: 31885 Main Street: SLALOM HILL RD Cross Street: SPRUCE\_PEAK\_RD Location: SW ADA ID: 95F92E42D219 Ramp Type: PerpDiag Initial Pass/Fail: Fail **Overall Compliance: No Severity Score:** 10

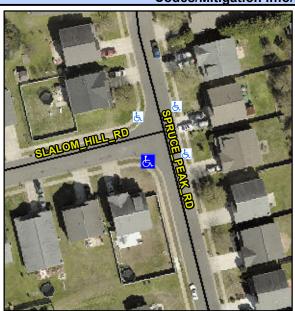
Field Measurements/Component Compliance						
Compliance Description		Data	Comp	liance	Description	Data
N/A	Ramp Length (in)	46.0	Yes	Ram	Slope (%)	6.3
No	Ramp Width (in)	39.0	No	Ram	XSlope (%)	3.6
N/A	Flare Type LT	N/A	N/A	I/A Flare Type RT		N/A
N/A	Flare Slope LT (%)	N/A	N/A	Flare	Slope RT (%)	N/A
N/A	Flare Traversable LT?	N/A	N/A	Flare Traversable RT?		N/A
N/A	Landing Length (in)	N/A	N/A	DWS	Provided?	N/A
N/A	Landing Width (in)	N/A	N/A	DWS	Contrast?	N/A
N/A	Landing Slope (%)	N/A	N/A	DWS	Length (in)	N/A
N/A	Landing X Slope (%)	N/A	N/A	DWS	Full Width?	N/A
N/A	Landing Curb? (Y/N)	N/A	N/A	DWS	Offset (in)	N/A
N/A	Shared Landing?	N/A				
N/A	Gutter Ponding?	N/A	N/A	Gutte	er Slope (%)	N/A
N/A	Gutter Lip Ht (in)	N/A	N/A	Gutte	er X Slope (%)	N/A
N/A	Painted X Walk1?	No	N/A	Paint	ed X Walk2?	No
	X Walk 1 Direction	То Е		X Wa	lk 2 Direction	To N
N/A	X Walk 1 Width (in)	N/A	N/A	X Wa	lk 2 Width (in)	N/A
	X Walk 1 Slope (%)	6.0		X Wa	lk 2 Slope (%)	2.5

X Walk 1 X Slope (%)	2.5		X Wa	lk 2 X Slope (%)	4.1
N/A	Ramp inside XWalk1?	N/A	N/A	Ram	o inside XWalk2?	N/A
	Road Slope (%)	1.5	N/A	Clear	Space?	N/A
	Road X Slope (%)	4.8	N/A	Clear	Space to XWalk (in)	N/A
N/A	Any Obstructions?	N/A	N/A	Storn	n Grate/Utility Hazard?	N/A
	Obstruction Type			Storn	n Grate/Utility Type	
		N/A				N/A
			Yes	Surfa	ce Condition? (G/P)	Good

Possible Solutions: Remove & Replace Curb Ramp With Two New Directional Ramps or Equivalent. Surveyor Notes: N/A PROW/ADA: R304.5.1, R304.5.3

Total Cost: 3200.00
