Access Compliance Report

Public Rights-of-Way

(Curb Ramps)

Intersection ID: 49126	Main Street: CARLOTA_CT	Cross Street: LEGOLAS_LN	Location: SE
ADA ID: 9603BCA336D4	Ramp Type: PerpDiag	Initial Pass/Fail: Fail	Overall Compliance: No
Codes/Mitigation Info/Possible Solution			Severity Score: 10
			Field Measurements/Component Compliance

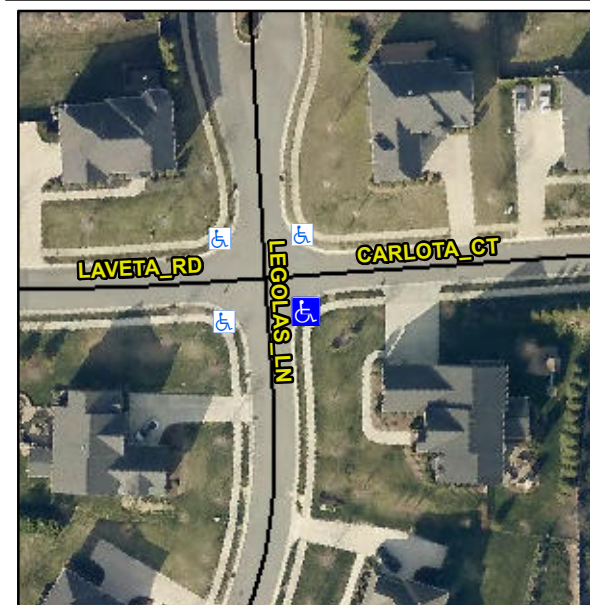
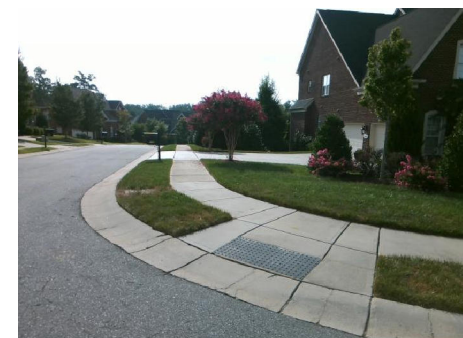
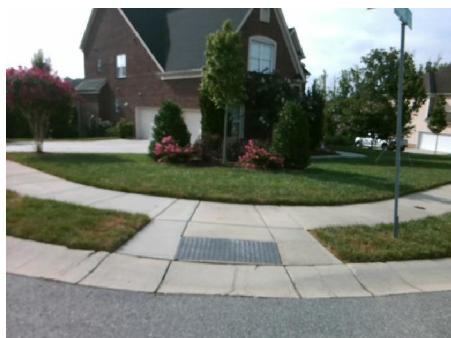
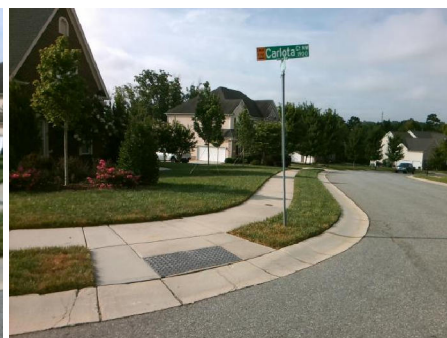
Not Found, R304.5.1, R304.5.3

Compliance	Description	Data	Compliance	Description	Data
N/A	Ramp Length (in)	48.0	Yes	Ramp Slope (%)	6.0
No	Ramp Width (in)	45.0	No	Ramp XSlope (%)	2.7
N/A	Flare Type LT	N/A	N/A	Flare Type RT	N/A
N/A	Flare Slope LT (%)	N/A	N/A	Flare Slope RT (%)	N/A
N/A	Flare Traversable LT?	N/A	N/A	Flare Traversable RT?	N/A
N/A	Landing Length (in)	N/A	N/A	DWS Provided?	N/A
N/A	Landing Width (in)	N/A	N/A	DWS Contrast?	N/A
N/A	Landing Slope (%)	N/A	N/A	DWS Length (in)	N/A
N/A	Landing X Slope (%)	N/A	N/A	DWS Full Width?	N/A
N/A	Landing Curb? (Y/N)	N/A	N/A	DWS Offset (in)	N/A
N/A	Shared Landing?	N/A			
N/A	Gutter Ponding?	N/A	N/A	Gutter Slope (%)	N/A
N/A	Gutter Lip Ht (in)	0.5	N/A	Gutter X Slope (%)	N/A
N/A	Painted X Walk1?	No	N/A	Painted X Walk2?	No
	X Walk 1 Direction	To N		X Walk 2 Direction	To W
N/A	X Walk 1 Width (in)	N/A	N/A	X Walk 2 Width (in)	N/A
	X Walk 1 Slope (%)	2.3		X Walk 2 Slope (%)	4.1
	X Walk 1 X Slope (%)	1.1		X Walk 2 X Slope (%)	3.3

N/A	Ramp inside XWalk1?	N/A	N/A	Ramp inside XWalk2?	N/A
	Road Slope (%)	0.3	N/A	Clear Space?	N/A
	Road X Slope (%)	3.7	N/A	Clear Space to XWalk (in)	N/A
N/A	Any Obstructions?	N/A	N/A	Storm Grate/Utility Hazard?	N/A
	Obstruction Type			Storm Grate/Utility Type	
		N/A			N/A
			Yes	Surface Condition? (G/P)	Good

Possible Solutions:

Remove & Replace Curb Ramp With Two New Directional Ramps or Equivalent.
