# Access Compliance Report

## Public Rights-of-Way

### (Curb Ramps)

Intersection ID: N/A	Main Street: SUMMERFIELD RIDGE LN	Cross Street: MILL VALLEY CT	Location: S
ADA ID: 963DF228E042	Ramp Type: PerpDiag	Initial Pass/Fail: Fail	Overall Compliance: No
Codes/Mitigation Info/Possible Solution		Field Measurements/Component Compliance	
Severity Score: 33.75

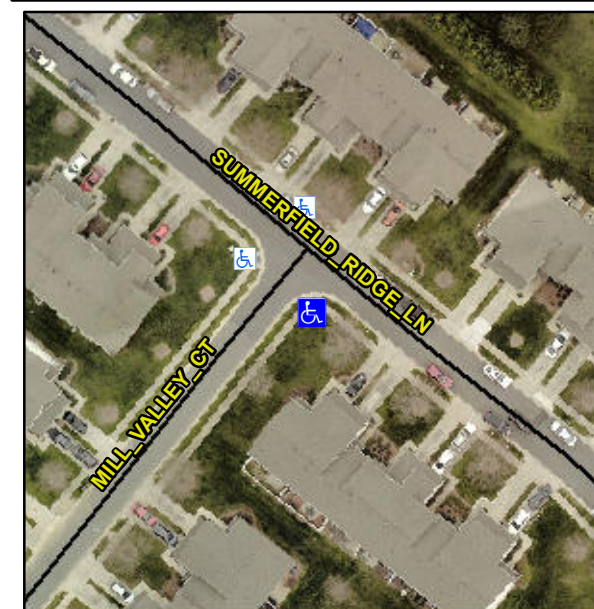
Compliance	Description	Data	Compliance	Description	Data
N/A	Ramp Length (in)	48.0	No	Ramp Slope (%)	8.6
No	Ramp Width (in)	36.0	No	Ramp XSlope (%)	6.5
N/A	Flare Type LT	N/A	N/A	Flare Type RT	N/A
N/A	Flare Slope LT (%)	N/A	N/A	Flare Slope RT (%)	N/A
N/A	Flare Traversable LT?	No	N/A	Flare Traversable RT?	No
N/A	Landing Length (in)	N/A	N/A	DWS Provided?	N/A
N/A	Landing Width (in)	N/A	N/A	DWS Contrast?	N/A
N/A	Landing Slope (%)	N/A	N/A	DWS Length (in)	N/A
N/A	Landing X Slope (%)	N/A	N/A	DWS Full Width?	N/A
N/A	Landing Curb? (Y/N)	N/A	N/A	DWS Offset (in)	N/A
N/A	Shared Landing?	N/A			
N/A	Gutter Ponding?	N/A	N/A	Gutter Slope (%)	N/A
N/A	Gutter Lip Ht (in)	N/A	N/A	Gutter X Slope (%)	N/A
N/A	Painted X Walk1?	No	N/A	Painted X Walk2?	No
	X Walk 1 Direction	To NE		X Walk 2 Direction	To NW
N/A	X Walk 1 Width (in)	N/A	N/A	X Walk 2 Width (in)	N/A
	X Walk 1 Slope (%)	1.7		X Walk 2 Slope (%)	2.5
	X Walk 1 X Slope (%)	1.4		X Walk 2 X Slope (%)	4.1

N/A	Ramp inside XWalk1?	N/A	N/A	Ramp inside XWalk2?	N/A
	Road Slope (%)	3.3	N/A	Clear Space?	N/A
	Road X Slope (%)	1.8	N/A	Clear Space to XWalk (in)	N/A
N/A	Any Obstructions?	N/A	N/A	Storm Grate/Utility Hazard?	N/A
	Obstruction Type			Storm Grate/Utility Type	
		N/A			N/A
			Yes	Surface Condition? (G/P)	Good

**Remove & Replace Curb Ramp With Two New Directional Ramps or Equivalent.**

**R304.5.1, R304.2.2, R304.5.3**
