# Access Compliance Report

## Public Rights-of-Way

### (Curb Ramps)

Intersection ID: 9711	Main Street: N_DAVIDSON_ST	Cross Street: PATTERSON_ST	Location: SW
ADA ID: 9645C521A978	Ramp Type: Perp	Initial Pass/Fail: Fail	Overall Compliance: No
Severity Score: 1.25			
Codes/Mitigation Info/Possible Solution		Field Measurements/Component Compliance

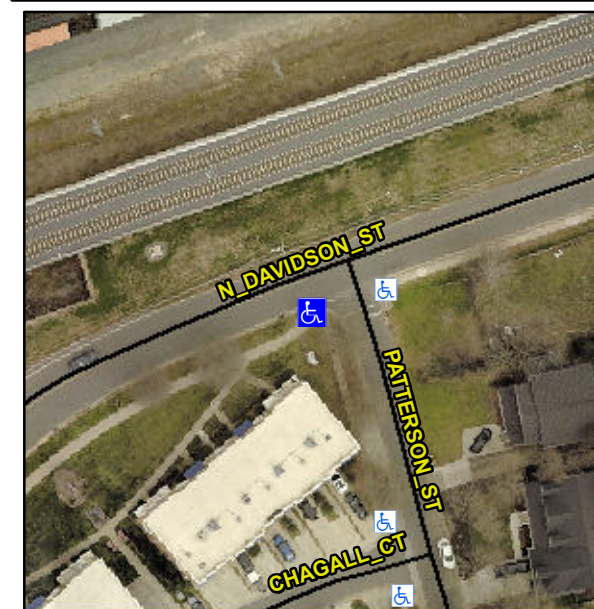
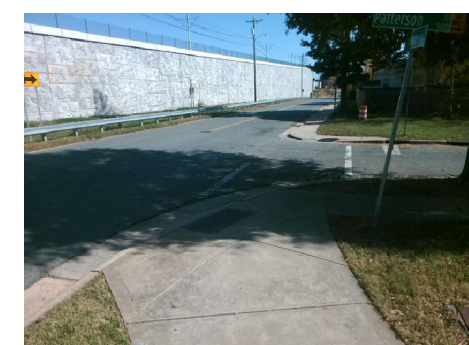
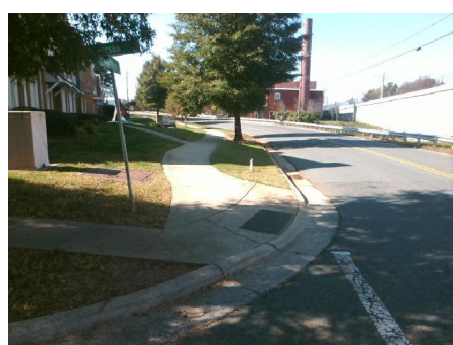
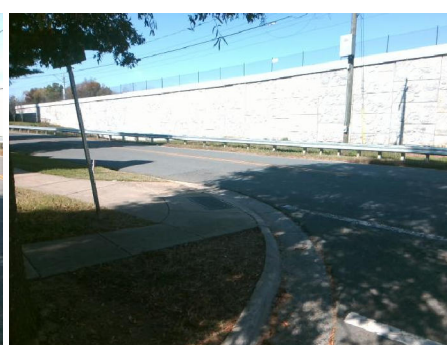
**Not Found, R304.5.3**

Compliance	Description	Data	Compliance	Description	Data
N/A	Ramp Length (in)	49.0	Yes	Ramp Slope (%)	5.6
Yes	Ramp Width (in)	48.0	No	Ramp XSlope (%)	2.7
N/A	Flare Type LT	N/A	N/A	Flare Type RT	N/A
N/A	Flare Slope LT (%)	N/A	N/A	Flare Slope RT (%)	N/A
N/A	Flare Traversable LT?	N/A	N/A	Flare Traversable RT?	N/A
N/A	Landing Length (in)	N/A	N/A	DWS Provided?	N/A
N/A	Landing Width (in)	N/A	N/A	DWS Contrast?	N/A
N/A	Landing Slope (%)	N/A	N/A	DWS Length (in)	N/A
N/A	Landing X Slope (%)	N/A	N/A	DWS Full Width?	N/A
N/A	Landing Curb? (Y/N)	N/A	N/A	DWS Offset (in)	N/A
N/A	Shared Landing?	N/A			
N/A	Gutter Ponding?	N/A	N/A	Gutter Slope (%)	N/A
N/A	Gutter Lip Ht (in)	1.0	N/A	Gutter X Slope (%)	N/A
N/A	Painted X Walk1?	No	N/A	Painted X Walk2?	N/A
	X Walk 1 Direction	To E		X Walk 2 Direction	N/A
N/A	X Walk 1 Width (in)	N/A	N/A	X Walk 2 Width (in)	N/A
	X Walk 1 Slope (%)	0.4		X Walk 2 Slope (%)	N/A
	X Walk 1 X Slope (%)	0.8		X Walk 2 X Slope (%)	N/A

N/A	Ramp inside XWalk1?	N/A	N/A	Ramp inside XWalk2?	N/A
	Road Slope (%)	N/A	N/A	Clear Space?	N/A
	Road X Slope (%)	N/A	N/A	Clear Space to XWalk (in)	N/A
N/A	Any Obstructions?	N/A	N/A	Storm Grate/Utility Hazard?	N/A
	Obstruction Type			Storm Grate/Utility Type	
		N/A			N/A
		Yes		Surface Condition? (G/P)	Good

**Remove & Replace Entire Ramp.**

**\$ 1850.00**
