Access Compliance Report Public Rights-of-Way (Curb Ramps)

Intersection ID: 52893	Main Street: TWITTER_LN				Street:	SANCTUARY_PL	Location:	NW			
ADA ID: 964ADC4C9678	Ramp T	Initial Pass/Fail: Fail Overall Compliance: No					22.5				
Codes/Mitigation Info/Possible Solution					Field Measurements/Component Compliance						
		Possible Solutions:							liance Description	Data

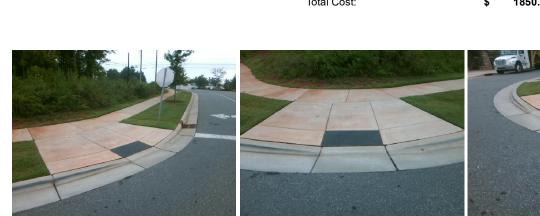
L. M.	A PARTY A	Remove & Replace Entire Ramp.			N/A	Ramp Length (in)	97.0	No	Ramp Slope (%)	8.7	
	- Mai	Remove & Replace		•	No	Ramp Width (in)	46.0	-	Ramp XSlope (%)	4.8	
	a free to				N/A	Flare Type LT	N/A		Flare Type RT	N/A	
	the second				N/A	Flare Slope LT (%)		N/A	Flare Slope RT (%)	N/A
