Access Compliance Report

Public Rights-of-Way

(Curb Ramps)

| Intersection ID: 27314 | Main Street: CHARTER_HILLS_RD | Cross Street: WILD_DOVE_LN | Location: SW |

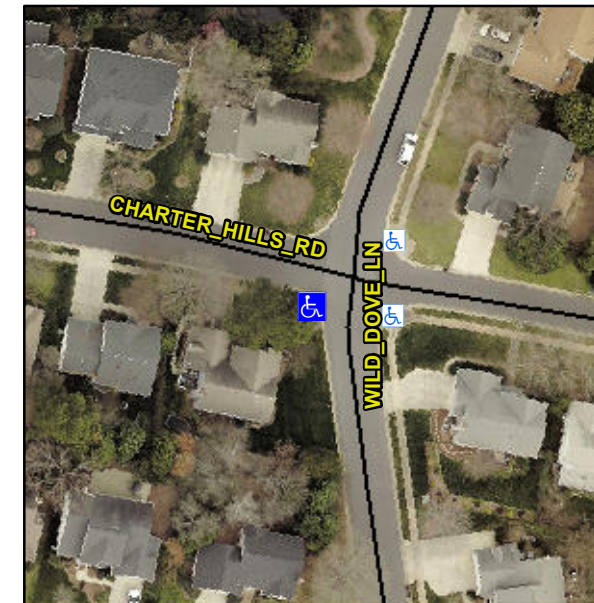
| ADA ID: 965F62CAC14A | Ramp Type: PerpDiag | Initial Pass/Fail: Fail | Overall Compliance: No |

Not Found, R304.5.1, R304.5.3

| Compliance | Description | Data | Compliance | Description | Data |
|---|---|---|---|---|---|
| N/A | Ramp Length (in) | 94.0 | Yes | Ramp Slope (%) | 5.5 |
| No | Ramp Width (in) | 39.0 | No | Ramp XSlope (%) | 4.1 |

Remove & Replace Curb Ramp With Two New Directional Ramps or Equivalent.
