Access Compliance Report

Public Rights-of-Way

(Curb Ramps)

Intersection ID: 29797	Main Street: CHELTON RIDGE LN	Cross Street: DESTIN LN	Location: NE
ADA ID: 966B7EE7177D	Ramp Type: PerpDiag	Initial Pass/Fail: Fail	Overall Compliance: No
Severity Score: 13.75			
Codes/Mitigation Info/Possible Solution		Field Measurements/Component Compliance

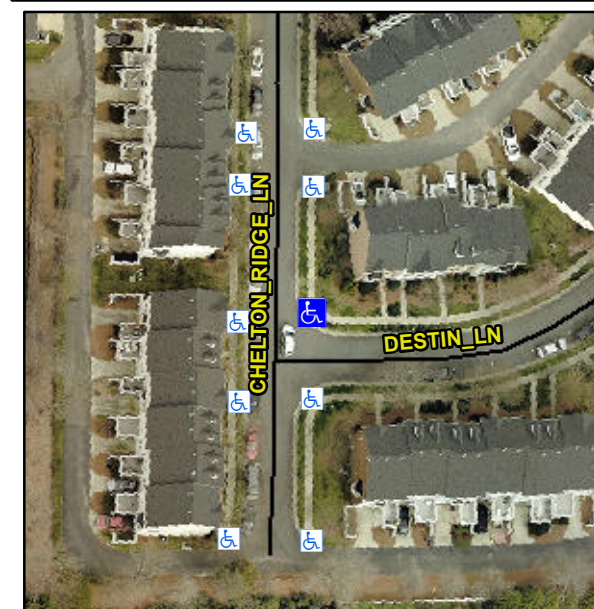
Compliance	Description	Data	Compliance	Description	Data
N/A	Ramp Length (in)	47.0	No	Ramp Slope (%)	11.9
Yes	Ramp Width (in)	57.0	No	Ramp XSlope (%)	3.5
N/A	Flare Type LT	N/A	N/A	Flare Type RT	N/A
N/A	Flare Slope LT (%)	N/A	N/A	Flare Slope RT (%)	N/A
N/A	Flare Traversable LT?	N/A	N/A	Flare Traversable RT?	N/A
N/A	Landing Length (in)	N/A	N/A	DWS Provided?	N/A
N/A	Landing Width (in)	N/A	N/A	DWS Contrast?	N/A
N/A	Landing Slope (%)	N/A	N/A	DWS Length (in)	N/A
N/A	Landing X Slope (%)	N/A	N/A	DWS Full Width?	N/A
N/A	Landing Curb? (Y/N)	N/A	N/A	DWS Offset (in)	N/A
N/A	Shared Landing?	N/A			
N/A	Gutter Ponding?	N/A	N/A	Gutter Slope (%)	N/A
N/A	Gutter Lip Ht (in)	N/A	N/A	Gutter X Slope (%)	N/A
N/A	Painted X Walk1?	No	N/A	Painted X Walk2?	No
	X Walk 1 Direction	To W		X Walk 2 Direction	To S
N/A	X Walk 1 Width (in)	N/A	N/A	X Walk 2 Width (in)	N/A
	X Walk 1 Slope (%)	1.0		X Walk 2 Slope (%)	4.8
	X Walk 1 X Slope (%)	3.7		X Walk 2 X Slope (%)	0.8

N/A	Ramp inside XWalk1?	N/A	N/A	Ramp inside XWalk2?	N/A
	Road Slope (%)	2.0	N/A	Clear Space?	N/A
	Road X Slope (%)	2.1	N/A	Clear Space to XWalk (in)	N/A
N/A	Any Obstructions?	N/A	N/A	Storm Grate/Utility Hazard?	N/A
	Obstruction Type			Storm Grate/Utility Type	
		N/A			N/A
		Yes		Surface Condition? (G/P)	Good

Possible Solutions:

Remove & Replace Curb Ramp With Two New Directional Ramps or Equivalent.
