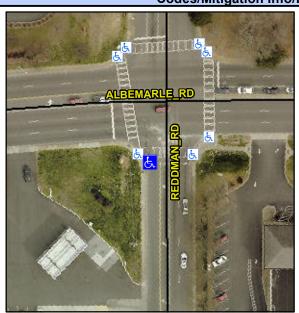
Intersection ID: 15094Main Street: ALBEMARLE\_RDCross Street: REDDMAN\_RDLocation:SWADA ID: 967EA1BD3025Ramp Type: PerpInitial Pass/Fail: FailOverall Compliance: NoSeverity Score: 33.75

Field Measurements/Component Compliance							
Comp	liance Description	Data	Comp	liance Description	Data		
N/A	Ramp Length (in)	59.0	No	Ramp Slope (%)	11.5		
No	Ramp Width (in)	40.0	No	Ramp XSlope (%)	6.4		
N/A	Flare Type LT	N/A	N/A	Flare Type RT	N/A		
N/A	Flare Slope LT (%)	N/A	N/A	Flare Slope RT (%)	N/A		
N/A	Flare Traversable LT?	N/A	N/A	Flare Traversable RT?	N/A		
N/A	Landing Length (in)	N/A	N/A	DWS Provided?	N/A		
N/A	Landing Width (in)	N/A	N/A	DWS Contrast?	N/A		
N/A	Landing Slope (%)	N/A	N/A	DWS Length (in)	N/A		
N/A	Landing X Slope (%)	N/A	N/A	DWS Full Width?	N/A		
N/A	Landing Curb? (Y/N)	N/A	N/A	DWS Offset (in)	N/A		
N/A	Shared Landing?	N/A					
N/A	Gutter Ponding?	N/A	N/A	Gutter Slope (%)	N/A		
N/A	Gutter Lip Ht (in)	N/A	N/A	Gutter X Slope (%)	N/A		
N/A	Painted X Walk1?	Yes	N/A	Painted X Walk2?	N/A		
	X Walk 1 Direction	To SW		X Walk 2 Direction	N/A		
N/A	X Walk 1 Width (in)	112.0	N/A	X Walk 2 Width (in)	N/A

X Walk 1 Slope (%)	2.7		X Walk 2 Slope (%)	N/A		
	X Walk 1 X Slope (%)	8.7		X Walk 2 X Slope (%)	N/A		
N/A	Ramp inside XWalk1?	Yes	N/A	Ramp inside XWalk2?	N/A		
	Road Slope (%)	N/A	N/A	Clear Space?	N/A		
	Road X Slope (%)	N/A	N/A	Clear Space to XWalk (in)	N/A		
N/A	Any Obstructions?	N/A	N/A	Storm Grate/Utility Hazard?	N/A		
	Obstruction Type			Storm Grate/Utility Type			
		N/A			N/A		
			Yes	Surface Condition? (G/P)	Good

-		
STATE OF	Possible Solutions:	9
The Park	Remove & Replace Entire Ramp.	ı
-		ı
		1
100		ı
		ı
1		ı
6	Surveyor Notes:	ı
	N/A	ı
		1
1		
7		
	PROW/ADA:	ı
1	Not Found, R304.5.1, R304.2.2,	1
-	R304.5.3	ı
		ı
		_
		ı
