Access Compliance Report

Public Rights-of-Way

(Curb Ramps)

Intersection ID: 49702	Main Street: SCOTTSMAN_TRACE_DR	Cross Street: MILL_RIVER_LN	Location: SW
ADA ID: 96950C6389C5	Ramp Type: PerpDiag	Initial Pass/Fail: Fail	Overall Compliance: No
Codes/Mitigation Info/Possible Solution		Field Measurements/Component Compliance

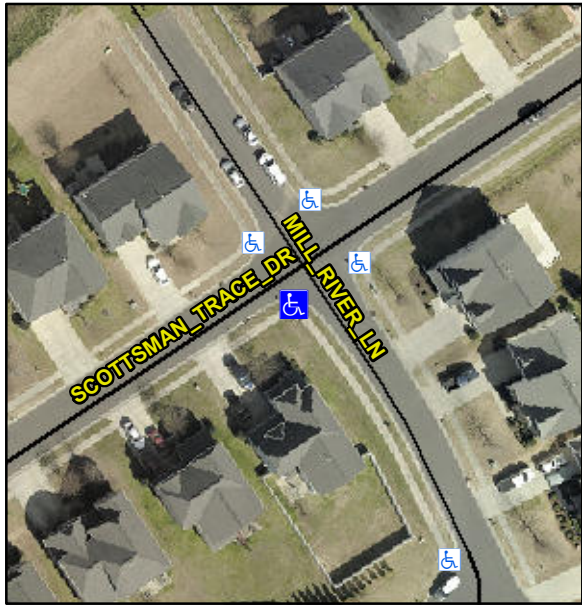
Compliance	Description	Data	Compliance	Description	Data
N/A	Ramp Length (in)	45.0	Yes	Ramp Slope (%)	7.6
No	Ramp Width (in)	46.0	No	Ramp XSlope (%)	5.9
N/A	Flare Type LT	N/A	N/A	Flare Type RT	N/A
N/A	Flare Slope LT (%)	N/A	N/A	Flare Slope RT (%)	N/A
N/A	Flare Traversable LT?	N/A	N/A	Flare Traversable RT?	N/A
N/A	Landing Length (in)	N/A	N/A	DWS Provided?	N/A
N/A	Landing Width (in)	N/A	N/A	DWS Contrast?	N/A
N/A	Landing Slope (%)	N/A	N/A	DWS Length (in)	N/A
N/A	Landing X Slope (%)	N/A	N/A	DWS Full Width?	N/A
N/A	Landing Curb? (Y/N)	N/A	N/A	DWS Offset (in)	N/A
N/A	Shared Landing?	N/A			
N/A	Gutter Ponding?	N/A	N/A	Gutter Slope (%)	N/A
N/A	Gutter Lip Ht (in)	N/A	N/A	Gutter X Slope (%)	N/A
N/A	Painted X Walk1?	No	N/A	Painted X Walk2?	No
	X Walk 1 Direction	To NE		X Walk 2 Direction	To NW
N/A	X Walk 1 Width (in)	N/A	N/A	X Walk 2 Width (in)	N/A
	X Walk 1 Slope (%)	3.4		X Walk 2 Slope (%)	1.5
	X Walk 1 X Slope (%)	3.1		X Walk 2 X Slope (%)	4.0

N/A	Ramp inside XWalk1?	N/A	N/A	Ramp inside XWalk2?	N/A
	Road Slope (%)	4.5	N/A	Clear Space?	N/A
	Road X Slope (%)	0.6	N/A	Clear Space to XWalk (in)	N/A
N/A	Any Obstructions?	N/A	N/A	Storm Grate/Utility Hazard?	N/A
	Obstruction Type			Storm Grate/Utility Type	
		N/A			N/A
			Yes	Surface Condition? (G/P)	Good

Possible Solutions:												
	Remove & Replace Curb Ramp With Two New Directional Ramps or Equivalent.												
	Surveyor Notes:												
	N/A												
	PROW/ADA:												
	Not Found, R304.5.1, R304.5.3												
Street 1 Name	MILL RIVER LN												
Stop Condition-Street 2	StopSign												
Street 2 Name	SCOTTMANS TRACE DR												
Stop Condition-Street 1	None												
Total Cost:		\$	3200.00
