Access Compliance Report

Public Rights-of-Way

(Curb Ramps)

| Intersection ID: 4973 | Main Street: MALLARD_CREEK_RD | Cross Street: MALLARD_CREEK_RD | Location: W |

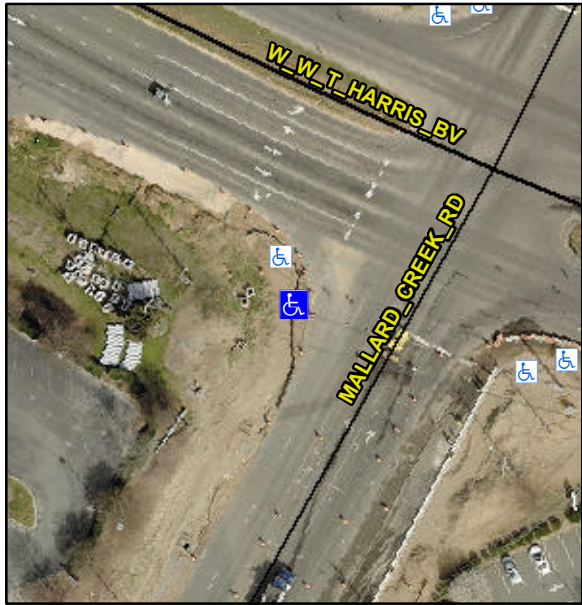
| ADA ID: 9698BD47B17E | Ramp Type: Perp | Initial Pass/Fail: Fail | Overall Compliance: No |
| | | | Severity Score: 28.75 |

| Codes/Mitigation Info/Possible Solution | | | Field Measurements/Component Compliance | | | | | |
|--|---|--|---|---|---|---|---|---|
| | Remove & Replace Entire Ramp. | | N/A | Ramp Length (in) | 104.0 | No | Ramp Slope (%) | 10.5 |
| | | | Yes | Ramp Width (in) | 60.0 | No | Ramp XSlope (%) | 3.5 |
| | Not Found, R304.2.2, R304.5.3, R302.7 | | N/A | Gutter Lip Ht (in) | N/A | N/A | Gutter X Slope (%) | N/A |
| | | | | | No | Surface Condition? (G/P) | Poor | |

| Codes/Mitigation Info/Possible Solution | | | Field Measurements/Component Compliance | | | | | |
|--|---|--|---|---|---|---|---|---|
| | Possible Solutions: | | Compliance | Description | Data | Compliance | Description | Data |
