# Access Compliance Report

## Public Rights-of-Way

### (Curb Ramps)

Intersection ID: 51323	Main Street: GLENMORE_GARDEN_DR	Cross Street: MCKEE_RD	Location: SW
ADA ID: 96B2C01B5653	Ramp Type: Perp	Initial Pass/Fail: Fail	Overall Compliance: No
Severity Score: 21.25			
Codes/Mitigation Info/Possible Solution		Field Measurements/Component Compliance

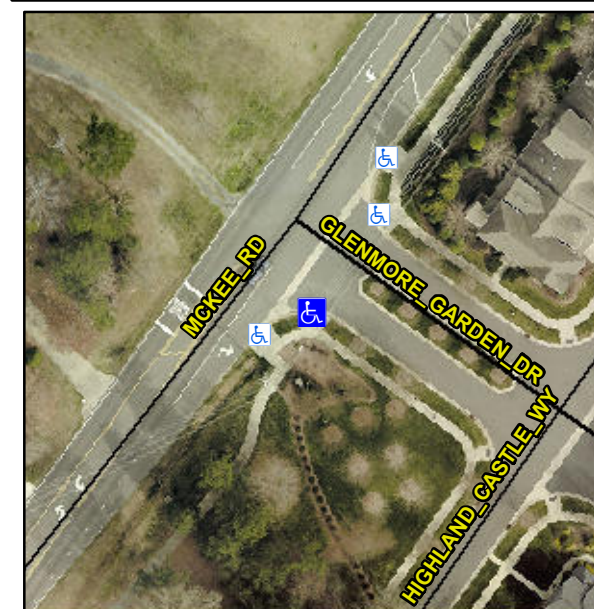
Compliance	Description	Data	Compliance	Description	Data
N/A	Ramp Length (in)	96.0	No	Ramp Slope (%)	10.5
No	Ramp Width (in)	46.0	Yes	Ramp XSlope (%)	1.9
N/A	Flare Type LT	N/A	N/A	Flare Type RT	N/A
N/A	Flare Slope LT (%)	N/A	N/A	Flare Slope RT (%)	N/A
N/A	Flare Traversable LT?	N/A	N/A	Flare Traversable RT?	N/A
N/A	Landing Length (in)	N/A	N/A	DWS Provided?	N/A
N/A	Landing Width (in)	N/A	N/A	DWS Contrast?	N/A
N/A	Landing Slope (%)	N/A	N/A	DWS Length (in)	N/A
N/A	Landing X Slope (%)	N/A	N/A	DWS Full Width?	N/A
N/A	Landing Curb? (Y/N)	N/A	N/A	DWS Offset (in)	N/A
N/A	Shared Landing?	N/A			
N/A	Gutter Ponding?	N/A	N/A	Gutter Slope (%)	N/A
N/A	Gutter Lip Ht (in)	N/A	N/A	Gutter X Slope (%)	N/A
N/A	Painted X Walk1?	No	N/A	Painted X Walk2?	N/A
	X Walk 1 Direction	To NE		X Walk 2 Direction	N/A
N/A	X Walk 1 Width (in)	N/A	N/A	X Walk 2 Width (in)	N/A
	X Walk 1 Slope (%)	1.4		X Walk 2 Slope (%)	N/A
	X Walk 1 X Slope (%)	0.4		X Walk 2 X Slope (%)	N/A

N/A	Ramp inside XWalk1?	N/A	N/A	Ramp inside XWalk2?	N/A
	Road Slope (%)	N/A	N/A	Clear Space?	N/A
	Road X Slope (%)	N/A	N/A	Clear Space to XWalk (in)	N/A
N/A	Any Obstructions?	N/A	N/A	Storm Grate/Utility Hazard?	N/A
	Obstruction Type			Storm Grate/Utility Type	
		N/A			N/A
			Yes	Surface Condition? (G/P)	Good

Possible Solutions:

**Remove & Replace Entire Ramp.**

**R304.5.1, R304.2.2**

Total Cost: \$ 1850.00
