## **Access Compliance Report Public Rights-of-Way** (Curb Ramps)

Intersection ID: 2581 Main Street: COLERIDGE CT Cross Street: FAIRVISTA\_DR Location: SE ADA ID: 96B2C50D1AE9 Ramp Type: PerpDiag Initial Pass/Fail: Fail **Overall Compliance: No** Severity Score: 21.25

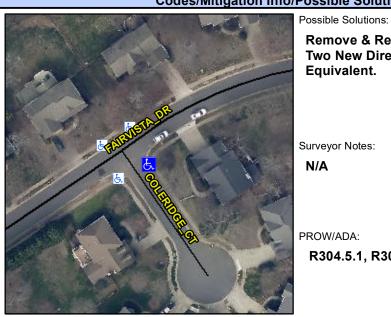
N
	N
Surveyor Notes:	N
N/A	N
	1
	N
	N
PROW/ADA:	N
R304.5.1, R304.5.3	N
	ŀ
	١
	N
	ı

Field Measurements/Component Compliance							
Comp	liance Description	Data	Comp	liance Description	Data		
N/A	Ramp Length (in)	52.0	Yes	Ramp Slope (%)	5.3		
No	Ramp Width (in)	39.5	No	Ramp XSlope (%)	5.1		
N/A	Flare Type LT	N/A	N/A	Flare Type RT	N/A		
N/A	Flare Slope LT (%)	N/A	N/A Flare Slope RT (%)		N/A		
N/A	Flare Traversable LT?	N/A	N/A	Flare Traversable RT?	N/A		
N/A	Landing Length (in)	N/A	N/A	DWS Provided?	N/A		
N/A	Landing Width (in)	N/A	N/A	DWS Contrast?	N/A		
N/A	Landing Slope (%)	N/A	N/A	DWS Length (in)	N/A		
N/A	Landing X Slope (%)	N/A	N/A	DWS Full Width?	N/A		
N/A	Landing Curb? (Y/N)	N/A	N/A	DWS Offset (in)	N/A		
N/A	Shared Landing?	N/A					
N/A	Gutter Ponding?	N/A	N/A	Gutter Slope (%)	N/A		
N/A	Gutter Lip Ht (in)	N/A	N/A	Gutter X Slope (%)	N/A		
N/A	Painted X Walk1?	No	N/A	Painted X Walk2?	No		
	X Walk 1 Direction	To NW		X Walk 2 Direction	To SW		
N/A	X Walk 1 Width (in)	N/A	N/A	X Walk 2 Width (in)	N/A

X Walk 1 Slope (%)	2.6		X Walk 2 Slope (%)	2.7		
	X Walk 1 X Slope (%)	3.0		X Walk 2 X Slope (%)	3.9		
N/A	Ramp inside XWalk1?	N/A	N/A	Ramp inside XWalk2?	N/A		
	Road Slope (%)	4.7	N/A	Clear Space?	N/A		
	Road X Slope (%)	3.0	N/A	Clear Space to XWalk (in)	N/A		
N/A	Any Obstructions?	N/A	N/A	Storm Grate/Utility Hazard?	N/A		
	Obstruction Type			Storm Grate/Utility Type			
		N/A			N/A		
			Yes	Surface Condition? (G/P)	Good		
		·	-

Street 1 Name Stop Condition-Street 2 Street 2 Name Stop Condition-Street 1 Two New Directional Ramps or Equivalent.

Remove & Replace Curb Ramp With

Total Cost: 3200.00
