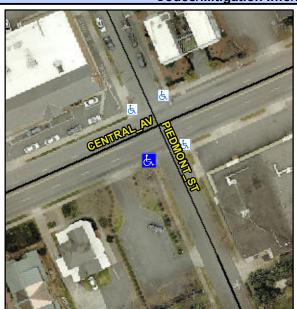
Intersection ID: 13002Main Street: CENTRAL_AVCross Street: PIEDMONT_STLocation:SWADA ID: 96B485643110Ramp Type: PerpInitial Pass/Fail: FailOverall Compliance: NoSeverity Score:12.5

| Possible Solutions: | <u>Co</u> |
|---|---|
| Not Found, R304.2.2 | N/A |

| | N/A | Ramp Length (in) | 56.0 | No | Ramp Slope (%) | 9.1 | | |

| Possible Solutions: | <u>Co</u> |
|---|---|
| Remove & Replace Entire Ramp. | N/A |
