# Access Compliance Report

## Public Rights-of-Way

### (Curb Ramps)

| Intersection ID: N/A | Main Street: S_BREVARD_ST | Cross Street: E_STONEWALL_ST | Location: W |

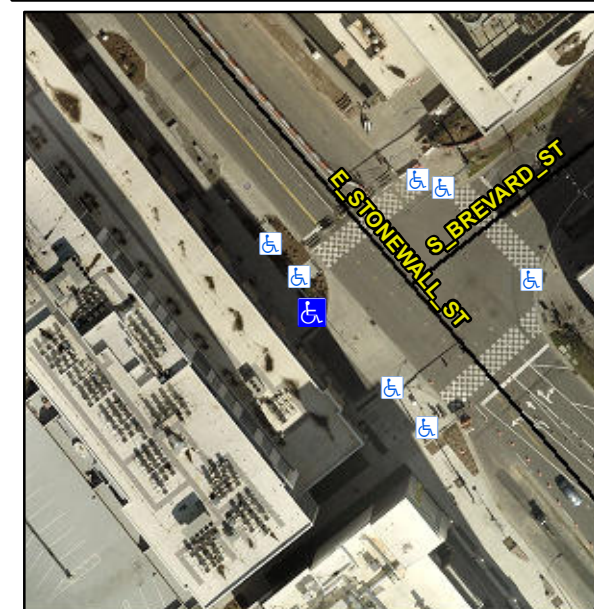
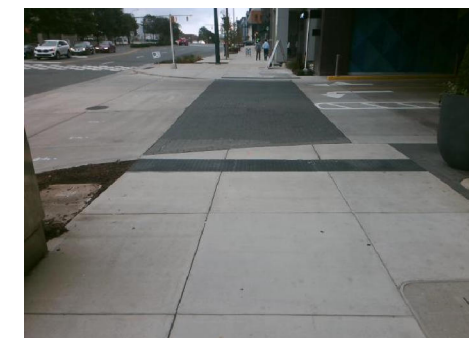
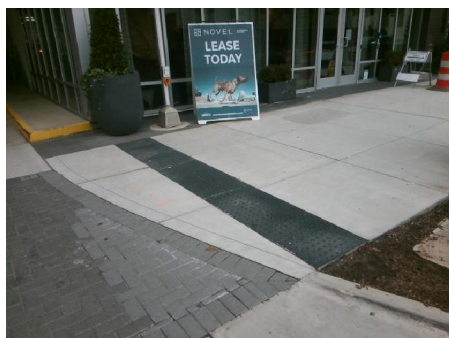
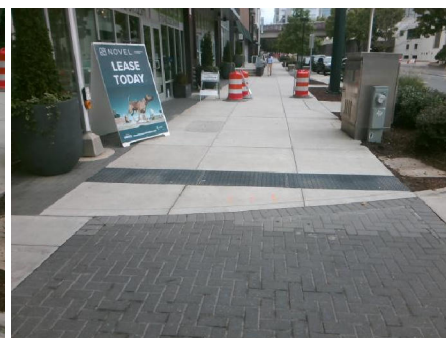
| ADA ID: 96B73A7E08F1 | Ramp Type: Directional1 | Initial Pass/Fail: Pass | Overall Compliance: No |

**R304.5.3, R304.2.2-Perp, R304.3.2-Para**

| Compliance | Description | Data | Compliance | Description | Data |
|---|---|---|---|---|---|
| No | Ramp XSlope (%) | 2.2 | | | |
| No | Landing Slope (%) | 2.3 | Yes | DWS Length (in) | 24.0 |

**Remove & Replace Entire Ramp.**
