Access Compliance Report

Public Rights-of-Way

(Curb Ramps)

| Intersection ID: 13420 | Main Street: S_TRYON_ST | Cross Street: W_BLAND_ST | Location: NE |

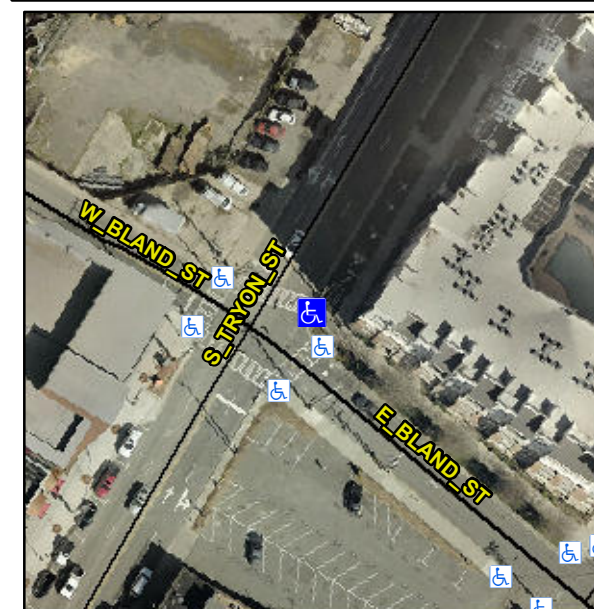
| ADA ID: 96BEA3F12AAC | Ramp Type: Perp | Initial Pass/Fail: Fail | Overall Compliance: No |
| Severity Score: 12.5 | | | |

Not Found, R304.2.2

| Compliance | Description | Data | Compliance | Description | Data |
|---|---|---|---|---|---|
| N/A | Ramp Length (in) | 67.0 | No | Ramp Slope (%) | 8.8 |

Remove & Replace Entire Ramp.

Total Cost: \$ 1850.00
