Access Compliance Report

Public Rights-of-Way

| Intersection ID: 21456 | Main Street: REGENT RIDGE LN | Cross Street: WITHERS MILL DR | Location: NW |
| ADA ID: 96C9D3C66345 | Ramp Type: PerpDiag | Initial Pass/Fail: Fail | Overall Compliance: No |

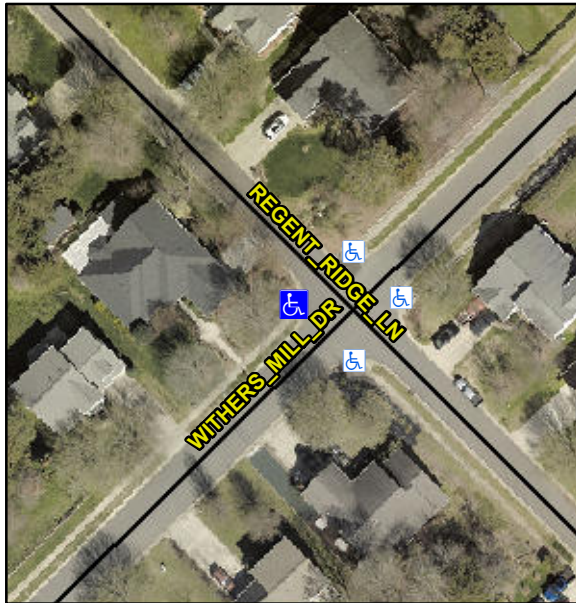
Field Measurements/Component Compliance

| Compliance | Description | Data | Compliance | Description | Data |
|---|---|---|---|---|---|
| No | Ramp Width (in) | 34.0 | No | Ramp XSlope (%) | 3.4 |

Remove & Replace Curb Ramp With Two New Directional Ramps or Equivalent.

R304.5.1, R304.5.3

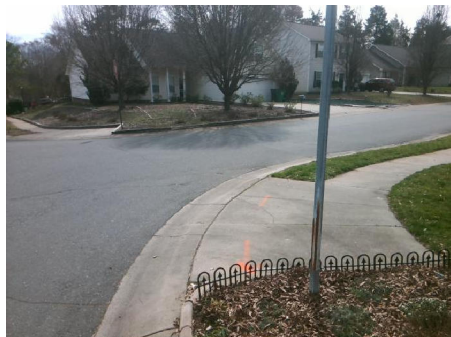
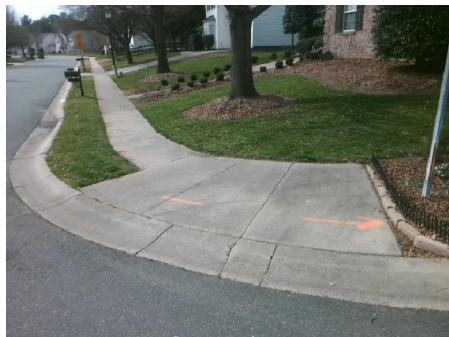
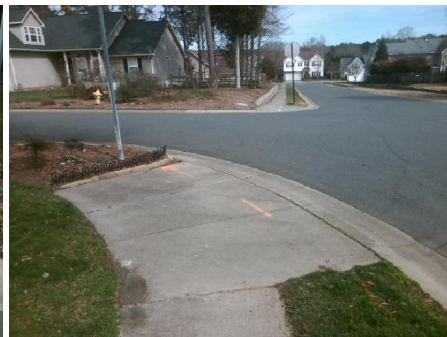
| Compliance | Description | Data | Compliance | Description | Data |
|---|---|---|---|---|---|
| N/A | Ramp Length (in) | 94.0 | Yes | Ramp Slope (%) | 5.8 |
| | | | Yes | Surface Condition? (G/P) | Good |
