## **Access Compliance Report Public Rights-of-Way** (Curb Ramps)

Intersection ID: 48865 Main Street: TIGRESS\_CT Cross Street: ERWIN\_RD Location: SE ADA ID: 96D370AC5042 Ramp Type: Perp Initial Pass/Fail: Fail **Overall Compliance: No Severity Score:** 12.5

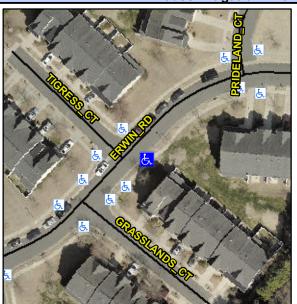
Field Measurements/Component Compliance							
Comp	liance Description	Data	Comp	liance Description	Data		
N/A	Ramp Length (in)	48.0	No	Ramp Slope (%)	10.0		
Yes	Ramp Width (in)	48.0	Yes	Ramp XSlope (%)	0.2		
N/A	Flare Type LT	N/A	N/A	Flare Type RT	N/A		
N/A	Flare Slope LT (%)	N/A	N/A	Flare Slope RT (%)	N/A		
N/A	Flare Traversable LT?	N/A	N/A	Flare Traversable RT?	N/A		
N/A	Landing Length (in)	N/A	N/A	DWS Provided?	N/A		
N/A	Landing Width (in)	N/A	N/A	DWS Contrast?	N/A		
N/A	Landing Slope (%)	N/A	N/A	DWS Length (in)	N/A		
N/A	Landing X Slope (%)	N/A	N/A	DWS Full Width?	N/A		
N/A	Landing Curb? (Y/N)	N/A	N/A	DWS Offset (in)	N/A		
N/A	Shared Landing?	N/A					
N/A	Gutter Ponding?	N/A	N/A	Gutter Slope (%)	N/A		
N/A	Gutter Lip Ht (in)	N/A	N/A	Gutter X Slope (%)	N/A		
N/A	Painted X Walk1?	No	N/A	Painted X Walk2?	N/A		
	X Walk 1 Direction	To N		X Walk 2 Direction	N/A		
N/A	X Walk 1 Width (in)	N/A	N/A	X Walk 2 Width (in)	N/A

X Walk 1 Slope (%)	3.6		X Walk 2 Slope (%)	N/A		
	X Walk 1 X Slope (%)	0.9		X Walk 2 X Slope (%)	N/A		
N/A	Ramp inside XWalk1?	N/A	N/A	Ramp inside XWalk2?	N/A		
	Road Slope (%)	N/A	N/A	Clear Space?	N/A		
	Road X Slope (%)	N/A	N/A	Clear Space to XWalk (in)	N/A		
N/A	Any Obstructions?	N/A	N/A	Storm Grate/Utility Hazard?	N/A		
	Obstruction Type			Storm Grate/Utility Type			
		N/A			N/A		
			Yes	Surface Condition? (G/P)	Good

Possible Solution	
Possible Solutions:	Con
Remove & Replace Entire Ramp.	N/A
	Yes
	N/A
	N/A
	N/A
	N/A
Surveyor Notes:	N/A
N/A	N/A
	N/A
	N/A
	N/A
PROW/ADA:	N/A
Not Found, R304.2.2	N/A
	N/A
	N/A
	N/A

N/A		
			N/A		
PROW/ADA:		N/A			
Not Found, R304.2.2					
			N/A		
			N/A		
			N/A		
Total Cost:	\$	1850.00	N/A
