# Access Compliance Report

## Public Rights-of-Way (Curb Ramps)

| Intersection ID: 12605 | Main Street: KENSINGTON_DR | Cross Street: THE_PLAZA | Location: SE |
| ADA ID: 96D3E5551D28 | Ramp Type: Directional1 | Initial Pass/Fail: Pass | Overall Compliance: No |

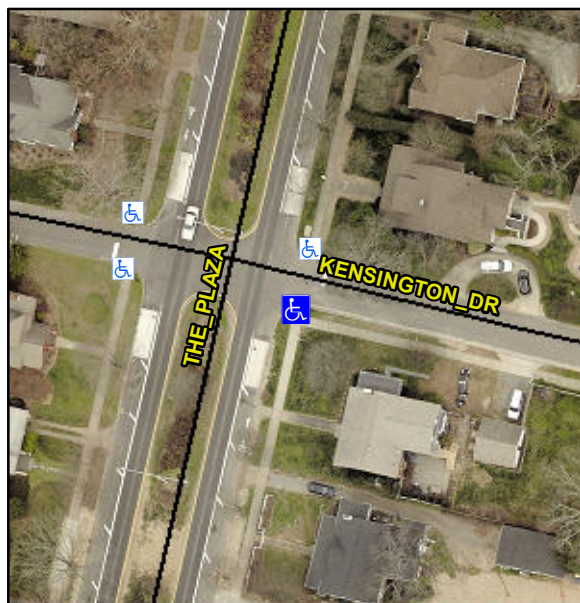
| Codes/Mitigation Info/Possible Solution | | | Severity Score: 10 |

**Not Found, R304.5.3, R305.1.4,  
R305.2, R302.7.2**

| Compliance | Description | Data | Compliance | Description | Data |
|---|---|---|---|---|---|
| Yes | Ramp Width (in) | 63.0 | No | Grade Break Slope (%) | 5.5 |
| Yes | Landing X Slope (%) | 1.9 | No | DWS Full Width? | No |
| N/A | Shared Landing? | No | No | DWS Offset RT (in) | 4.0 |
| No | Gutter Lip Ht (in) | 0.3 | No | Gutter X Slope (%) | 3.1 |

**Remove & Replace Entire Ramp.  
Remove & Replace Gutter.**
