# Access Compliance Report

## Public Rights-of-Way (Curb Ramps)

| Intersection ID: 49249 | Main Street: BOOMERANG_WY | Cross Street: PROSPERITY_VIEW_DR | Location: SW |
| ADA ID: 96D3FA13B6C9 | Ramp Type: BlendTrans1 | Initial Pass/Fail: Pass | Overall Compliance: No |

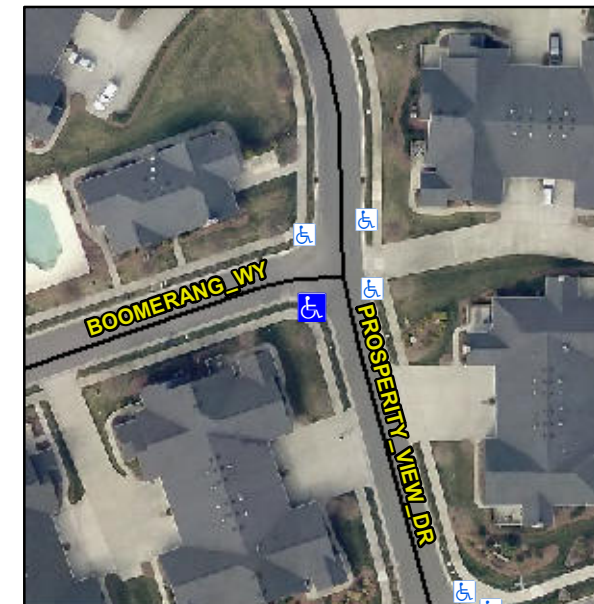
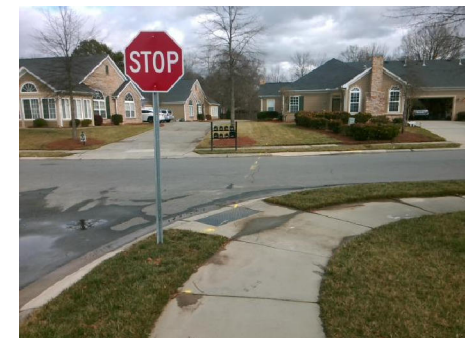
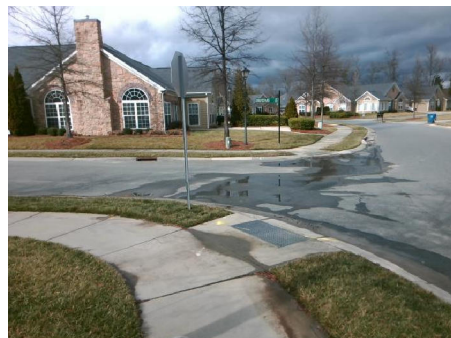
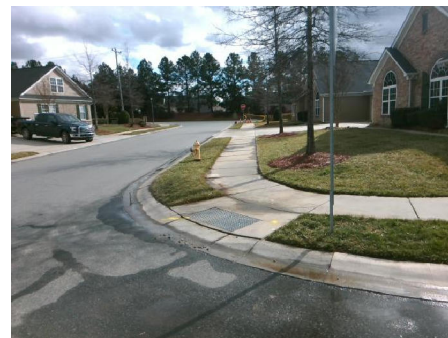
**Not Found, R302.7, R302.7.2, R304.5.4**

| Compliance | Description | Data | Compliance | Description | Data |
|---|---|---|---|---|---|
| No | Gutter Ponding? | Yes | No | Gutter Slope (%) | 10.6 |
| No | Gutter Lip Ht (in) | 0.5 | Yes | Gutter X Slope (%) | 0.7 |
| | | | No | Curb Slope (%) | 12.3 |

**Remove & Replace Curb Slope and Extend Ramp. Remove & Replace Gutter.**

Total Cost: \$ 2750.00
