Intersection ID: 7944	Main Street: DAVID_AV	Cross Street: RUNNING_DEER_RD	Location:	N/A
ADA ID: 96DD0E7AD368	Ramp Type: Perp	Initial Pass/Fail: Fail	Overall Compliance: No	Severity Score: 8.75

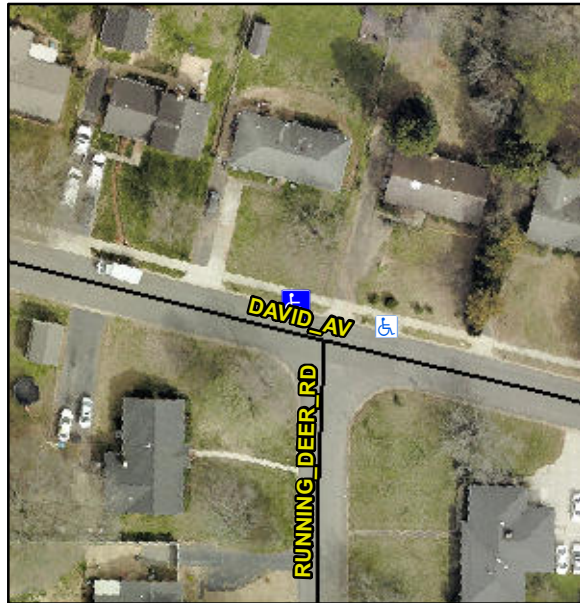
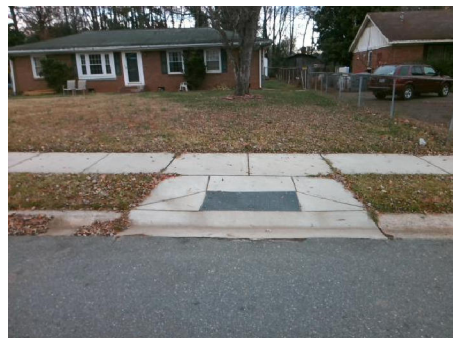
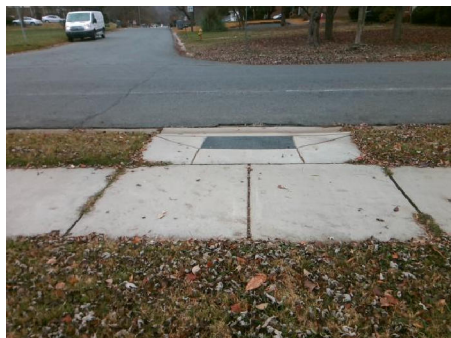
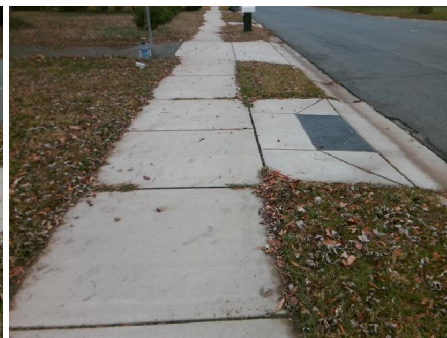
Not Found, R304.5.1

Compliance	Description	Data	Compliance	Description	Data
N/A	Ramp Length (in)	47.0	Yes	Ramp Slope (%)	7.2
No	Ramp Width (in)	47.5	Yes	Ramp XSlope (%)	1.9
N/A	Flare Type LT	N/A	N/A	Flare Type RT	N/A
N/A	Flare Slope LT (%)	N/A	N/A	Flare Slope RT (%)	N/A
N/A	Flare Traversable LT?	N/A	N/A	Flare Traversable RT?	N/A
N/A	Landing Length (in)	N/A	N/A	DWS Provided?	N/A
N/A	Landing Width (in)	N/A	N/A	DWS Contrast?	N/A
N/A	Landing Slope (%)	N/A	N/A	DWS Length (in)	N/A
N/A	Landing X Slope (%)	N/A	N/A	DWS Full Width?	N/A
N/A	Landing Curb? (Y/N)	N/A	N/A	DWS Offset (in)	N/A
N/A	Shared Landing?	N/A			
N/A	Gutter Ponding?	N/A	N/A	Gutter Slope (%)	N/A
N/A	Gutter Lip Ht (in)	N/A	N/A	Gutter X Slope (%)	N/A
N/A	Painted X Walk1?	No	N/A	Painted X Walk2?	N/A
	X Walk 1 Direction	To S		X Walk 2 Direction	N/A
N/A	X Walk 1 Width (in)	N/A	N/A	X Walk 2 Width (in)	N/A
	X Walk 1 Slope (%)	5.6		X Walk 2 Slope (%)	N/A
	X Walk 1 X Slope (%)	2.7		X Walk 2 X Slope (%)	N/A

N/A	Ramp inside XWalk1?	N/A	N/A	Ramp inside XWalk2?	N/A
	Road Slope (%)	2.7	N/A	Clear Space?	N/A
	Road X Slope (%)	5.6	N/A	Clear Space to XWalk (in)	N/A
N/A	Any Obstructions?	N/A	N/A	Storm Grate/Utility Hazard?	N/A
	Obstruction Type			Storm Grate/Utility Type	
		N/A			N/A
			Yes	Surface Condition? (G/P)	Good

Remove & Replace Entire Ramp.

Total Cost: \$ 1850.00
