Access Compliance Report

Public Rights-of-Way

(Curb Ramps)

| Intersection ID: 13936 | Main Street: S_KINGS_DR | Cross Street: CHARLOTTETOWNE_AV | Location: SW |

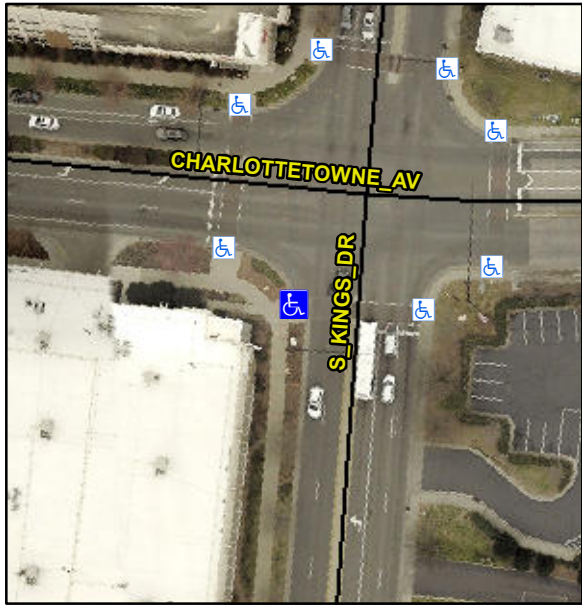
| ADA ID: 96E23CD309FF | Ramp Type: Perp | Initial Pass/Fail: Fail | Overall Compliance: No |

| Codes/Mitigation Info/Possible Solution | | | Field Measurements/Component Compliance | | | | | |
|--|---|---|---|---|---|---|---|---|
| | Remove & Replace Entire Ramp. | | N/A | Ramp Length (in) | 48.0 | No | Ramp Slope (%) | 8.5 |
| | | | Yes | Ramp Width (in) | 48.0 | No | Ramp XSlope (%) | 2.6 |
| PROW/ADA: | | Not Found, R304.2.2, R304.5.3 | N/A | Shared Landing? | N/A | | | |

| Codes/Mitigation Info/Possible Solution | | | Field Measurements/Component Compliance | | | | | |
|--|---|---|---|---|---|---|---|---|
| <div>Street 1 Name<div>S KINGS DR</div>Stop Condition-Street 2<div>Signal</div>Street 2 Name<div>N/A</div>Stop Condition-Street 1<div>N/A</div></div> | Possible Solutions: | | Compliance | Description | Data | Compliance | Description | Data |
| Total Cost: | | \$ 1850.00 | | | | | | |
