Access Compliance Report

(Curb Ramps)

Intersection ID: 20571	Main Street: CAMERON_VALLEY_PY	Cross Street: FAIRVIEW_RD	Location: SE
ADA ID: 96F1424E323A	Ramp Type: PerpDiag	Initial Pass/Fail: Fail	Overall Compliance: No
		Severity Score: 12.5

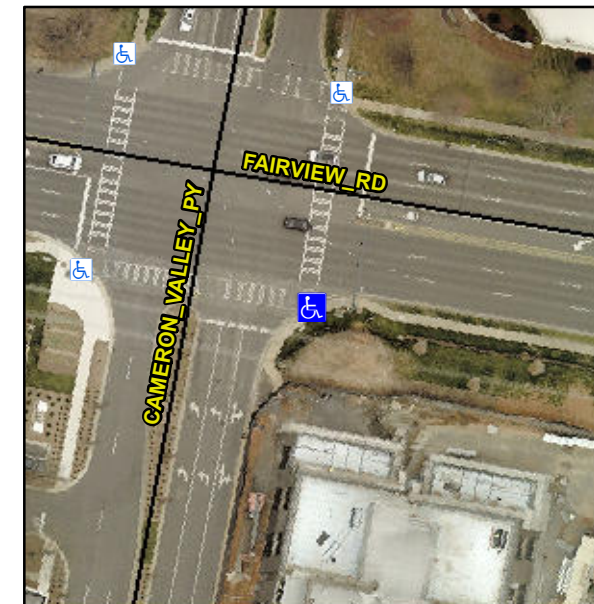
Not Found, R304.2.2

Compliance	Description	Data	Compliance	Description	Data
N/A	Ramp Length (in)	30.0	No	Ramp Slope (%)	8.8
Yes	Ramp Width (in)	51.5	Yes	Ramp XSlope (%)	1.2
N/A	Flare Type LT	N/A	N/A	Flare Type RT	N/A
N/A	Flare Slope LT (%)	N/A	N/A	Flare Slope RT (%)	N/A
N/A	Flare Traversable LT?	N/A	N/A	Flare Traversable RT?	N/A
N/A	Landing Length (in)	N/A	N/A	DWS Provided?	N/A
N/A	Landing Width (in)	N/A	N/A	DWS Contrast?	N/A
N/A	Landing Slope (%)	N/A	N/A	DWS Length (in)	N/A
N/A	Landing X Slope (%)	N/A	N/A	DWS Full Width?	N/A
N/A	Landing Curb? (Y/N)	N/A	N/A	DWS Offset (in)	N/A
N/A	Shared Landing?	N/A			
N/A	Gutter Ponding?	N/A	N/A	Gutter Slope (%)	N/A
N/A	Gutter Lip Ht (in)	N/A	N/A	Gutter X Slope (%)	N/A
N/A	Painted X Walk1?	Yes	N/A	Painted X Walk2?	Yes
	X Walk 1 Direction	To NE		X Walk 2 Direction	To NW
N/A	X Walk 1 Width (in)	105.0	N/A	X Walk 2 Width (in)	105.0
	X Walk 1 Slope (%)	0.1		X Walk 2 Slope (%)	0.5
	X Walk 1 X Slope (%)	0.7		X Walk 2 X Slope (%)	0.1

N/A	Ramp inside XWalk1?	Yes	N/A	Ramp inside XWalk2?	Yes
	Road Slope (%)	0.4	N/A	Clear Space?	N/A
	Road X Slope (%)	4.7	N/A	Clear Space to XWalk (in)	N/A
N/A	Any Obstructions?	N/A	N/A	Storm Grate/Utility Hazard?	N/A
	Obstruction Type			Storm Grate/Utility Type	
		N/A			N/A
		Yes		Surface Condition? (G/P)	Good

Remove & Replace Curb Ramp With Two New Directional Ramps or Equivalent.
