Access Compliance Report

Public Rights-of-Way

(Curb Ramps)

Intersection ID: 45068	Main Street: DARBYWINE_DR	Cross Street: PAULINE_LN	Location: NW
ADA ID: 96F25C31062B	Ramp Type: PerpDiag	Initial Pass/Fail: Pass	Overall Compliance: No
Codes/Mitigation Info/Possible Solution		Field Measurements/Component Compliance	
		Severity Score: 5

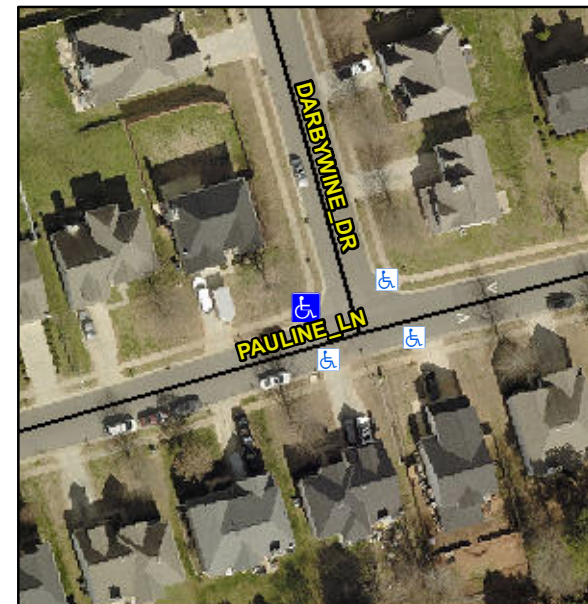
Not Found, R305.2, R304.5.4

Compliance	Description	Data	Compliance	Description	Data
N/A	Ramp Length (in)	48.0	Yes	Ramp Slope (%)	5.9
Yes	Ramp Width (in)	48.0	Yes	Ramp XSlope (%)	0.6
N/A	Flare Type LT	Sloped	N/A	Flare Type RT	N/A
N/A	Flare Slope LT (%)	5.0	Yes	Flare Slope RT (%)	5.7
N/A	Flare Traversable LT?	Yes	N/A	Flare Traversable RT?	Yes
Yes	Landing Length (in)	48.0	Yes	DWS Provided?	Yes
Yes	Landing Width (in)	48.0	Yes	DWS Contrast?	Yes
Yes	Landing Slope (%)	1.8	Yes	DWS Length (in)	24.5
Yes	Landing X Slope (%)	0.9	Yes	DWS Full Width?	Yes
N/A	Landing Curb? (Y/N)	No	No	DWS Offset (in)	3.5
N/A	Shared Landing?	No			
Yes	Gutter Ponding?	No	No	Gutter Slope (%)	14.5
Yes	Gutter Lip Ht (in)	0.0	Yes	Gutter X Slope (%)	0.5
N/A	Painted X Walk1?	No	N/A	Painted X Walk2?	No
	X Walk 1 Direction	To S		X Walk 2 Direction	To E
N/A	X Walk 1 Width (in)	N/A	N/A	X Walk 2 Width (in)	N/A
	X Walk 1 Slope (%)	0.8		X Walk 2 Slope (%)	0.4
	X Walk 1 X Slope (%)	0.1		X Walk 2 X Slope (%)	1.9

N/A	Ramp inside XWalk1?	N/A	N/A	Ramp inside XWalk2?	N/A
	Road Slope (%)	0.1	N/A	Clear Space?	Yes
	Road X Slope (%)	1.0	N/A	Clear Space to XWalk (in)	N/A
Yes	Any Obstructions?	No	Yes	Storm Grate/Utility Hazard?	No
	Obstruction Type			Storm Grate/Utility Type	
		N/A			N/A
		Yes		Surface Condition? (G/P)	Good

Remove & Replace Curb Ramp With Two New Directional Ramps or Equivalent. Remove & Replace Gutter.
