# Access Compliance Report

## Public Rights-of-Way

### (Curb Ramps)

Intersection ID: 3506	Main Street: MT_HOLLY-HUNTERSVILLE_RD	Cross Street: BEATTIES_FORD_RD	Location: SW
ADA ID: 96FBAD6BF367	Ramp Type: Perp	Initial Pass/Fail: Fail	Overall Compliance: No
Severity Score: 8.75			
Codes/Mitigation Info/Possible Solution		Field Measurements/Component Compliance

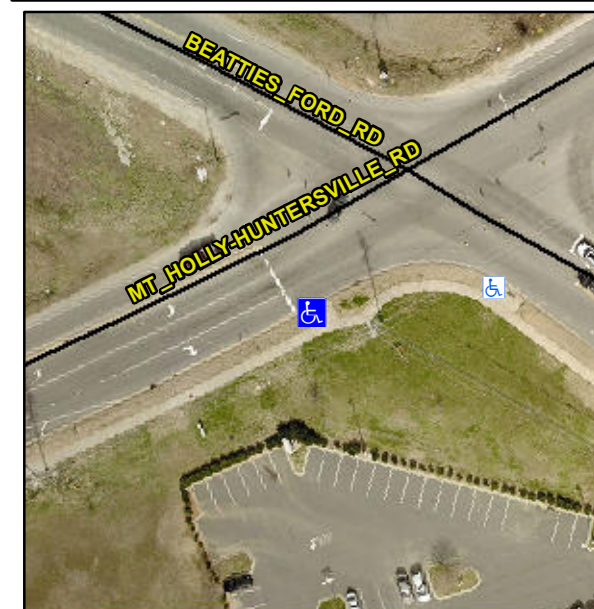
**Not Found, R304.5.1**

Compliance	Description	Data	Compliance	Description	Data
N/A	Ramp Length (in)	102.0	Yes	Ramp Slope (%)	5.5
No	Ramp Width (in)	47.0	Yes	Ramp XSlope (%)	1.3
N/A	Flare Type LT	N/A	N/A	Flare Type RT	N/A
N/A	Flare Slope LT (%)	N/A	N/A	Flare Slope RT (%)	N/A
N/A	Flare Traversable LT?	N/A	N/A	Flare Traversable RT?	N/A
N/A	Landing Length (in)	N/A	N/A	DWS Provided?	N/A
N/A	Landing Width (in)	N/A	N/A	DWS Contrast?	N/A
N/A	Landing Slope (%)	N/A	N/A	DWS Length (in)	N/A
N/A	Landing X Slope (%)	N/A	N/A	DWS Full Width?	N/A
N/A	Landing Curb? (Y/N)	N/A	N/A	DWS Offset (in)	N/A
N/A	Shared Landing?	N/A			
N/A	Gutter Ponding?	N/A	N/A	Gutter Slope (%)	N/A
N/A	Gutter Lip Ht (in)	N/A	N/A	Gutter X Slope (%)	N/A
N/A	Painted X Walk1?	No	N/A	Painted X Walk2?	N/A
	X Walk 1 Direction	To N		X Walk 2 Direction	N/A
N/A	X Walk 1 Width (in)	N/A	N/A	X Walk 2 Width (in)	N/A
	X Walk 1 Slope (%)	2.2		X Walk 2 Slope (%)	N/A
	X Walk 1 X Slope (%)	2.0		X Walk 2 X Slope (%)	N/A

N/A	Ramp inside XWalk1?	N/A	N/A	Ramp inside XWalk2?	N/A
	Road Slope (%)	2.0	N/A	Clear Space?	N/A
	Road X Slope (%)	2.2	N/A	Clear Space to XWalk (in)	N/A
N/A	Any Obstructions?	N/A	N/A	Storm Grate/Utility Hazard?	N/A
	Obstruction Type			Storm Grate/Utility Type	
		N/A			N/A
			Yes	Surface Condition? (G/P)	Good

**Remove & Replace Entire Ramp.**

Total Cost: \$ 1850.00
