Access Compliance Report

Public Rights-of-Way

(Curb Ramps)

Intersection ID: 31486	Main Street: CLOVER_GAP_DR	Cross Street: ELISE_MARIE_DR	Location: E
ADA ID: 9713FC30C6B9	Ramp Type: Perp	Initial Pass/Fail: Fail	Overall Compliance: No
Codes/Mitigation Info/Possible Solution		Field Measurements/Component Compliance	
Severity Score: 8.75

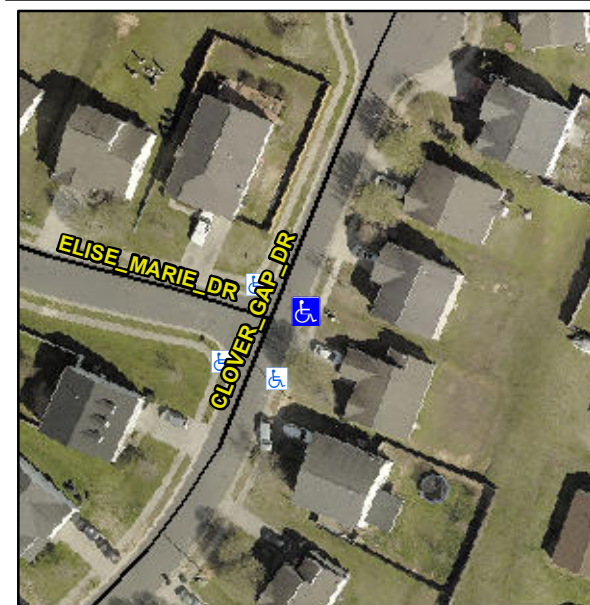
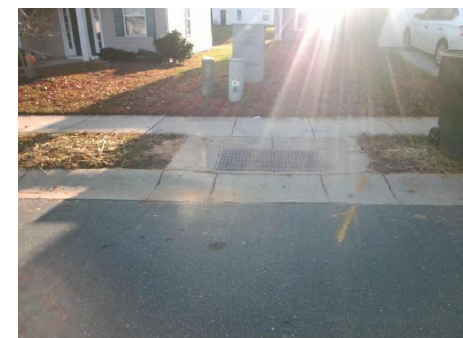
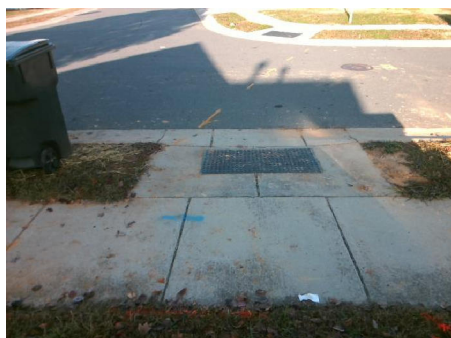
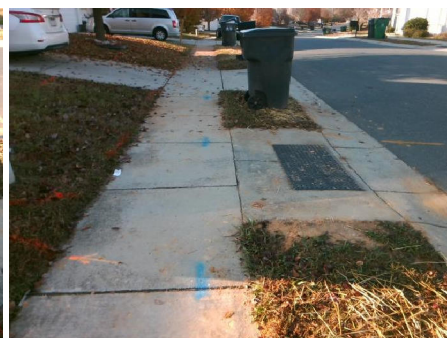
Not Found, R304.5.1

Compliance	Description	Data	Compliance	Description	Data
N/A	Ramp Length (in)	48.0	Yes	Ramp Slope (%)	8.1
No	Ramp Width (in)	45.0	Yes	Ramp XSlope (%)	0.4
N/A	Flare Type LT	N/A	N/A	Flare Type RT	N/A
N/A	Flare Slope LT (%)	N/A	N/A	Flare Slope RT (%)	N/A
N/A	Flare Traversable LT?	N/A	N/A	Flare Traversable RT?	N/A
N/A	Landing Length (in)	N/A	N/A	DWS Provided?	N/A
N/A	Landing Width (in)	N/A	N/A	DWS Contrast?	N/A
N/A	Landing Slope (%)	N/A	N/A	DWS Length (in)	N/A
N/A	Landing X Slope (%)	N/A	N/A	DWS Full Width?	N/A
N/A	Landing Curb? (Y/N)	N/A	N/A	DWS Offset (in)	N/A
N/A	Shared Landing?	N/A			
N/A	Gutter Ponding?	N/A	N/A	Gutter Slope (%)	N/A
N/A	Gutter Lip Ht (in)	N/A	N/A	Gutter X Slope (%)	N/A
N/A	Painted X Walk1?	No	N/A	Painted X Walk2?	N/A
	X Walk 1 Direction	To NW		X Walk 2 Direction	N/A
N/A	X Walk 1 Width (in)	N/A	N/A	X Walk 2 Width (in)	N/A
	X Walk 1 Slope (%)	3.1		X Walk 2 Slope (%)	N/A
	X Walk 1 X Slope (%)	0.6		X Walk 2 X Slope (%)	N/A

N/A	Ramp inside XWalk1?	N/A	N/A	Ramp inside XWalk2?	N/A
	Road Slope (%)	N/A	N/A	Clear Space?	N/A
	Road X Slope (%)	N/A	N/A	Clear Space to XWalk (in)	N/A
N/A	Any Obstructions?	N/A	N/A	Storm Grate/Utility Hazard?	N/A
	Obstruction Type			Storm Grate/Utility Type	
		N/A			N/A
			Yes	Surface Condition? (G/P)	Good

Possible Solutions:

Remove & Replace Entire Ramp.
